ANDREW JACKSON/ HORACE MANN SCHOOL CIPR

Date: April 09, 2019

Facility Address: 40 Armington Street, Allston

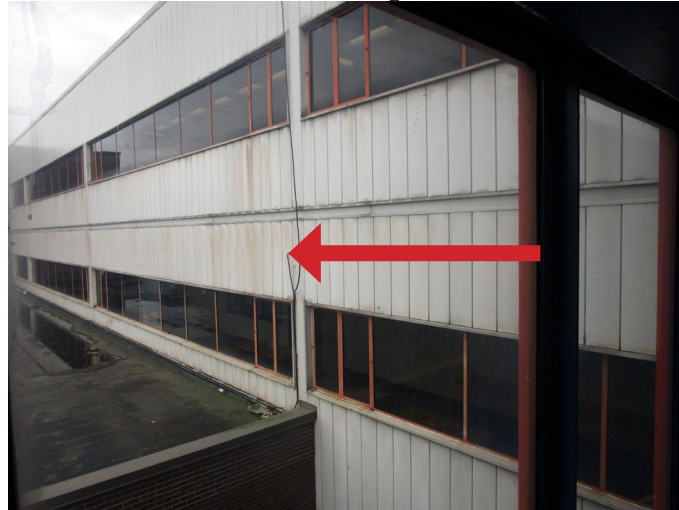
View of North side of Back Building

NOTE: Rusting visible on the North side of the Back Building

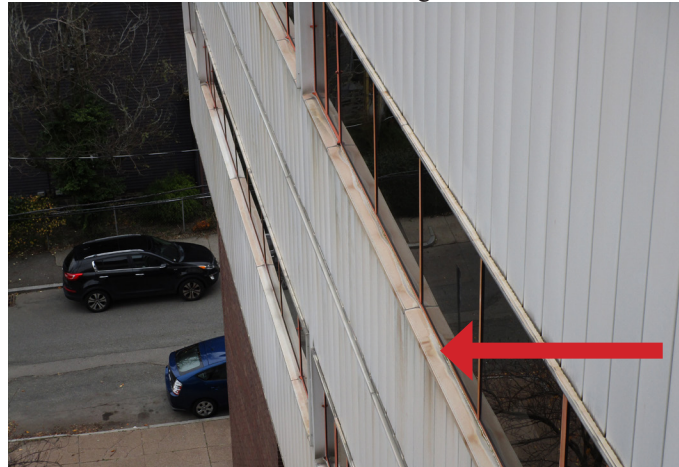
View from North side of Back Building

NOTE: Rusting visible on window sill and jamb of Back Building. The interface detail between metal panel and window is a thermal bridge with an inadequate weather barrier. This represents a significant risk for energy loss and water infiltration.

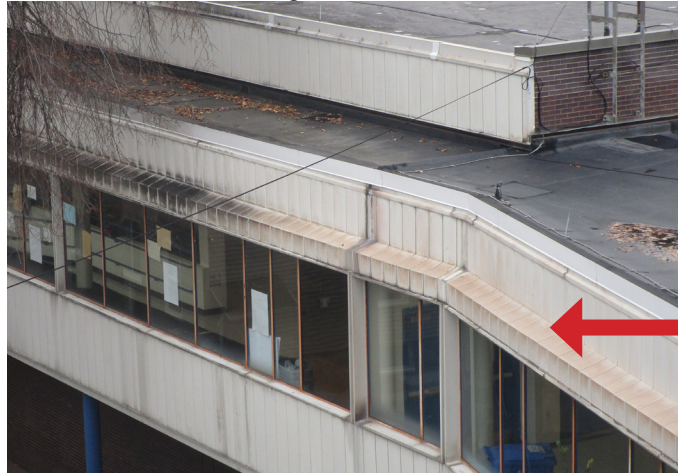
View of West Side of Ramp

NOTE: Rusting and dirt on ramp connecting the Front and Back building.

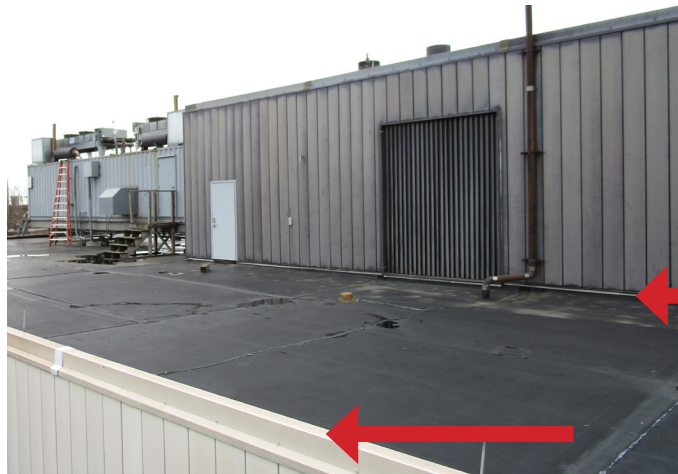
Mechanical Penthouse

NOTE: The existing metal wall panel does not extend far enough above the roof to provide a sufficient termination for the roof membrane. When the metal panel meets a lower roof there is not sufficient space to provide good termination details.

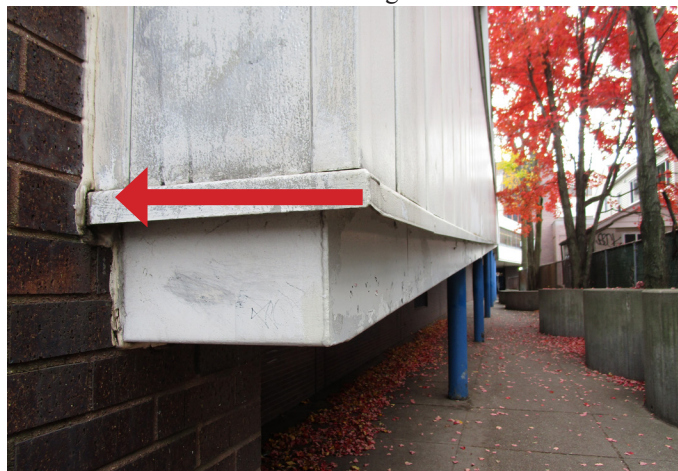
View from North side of Connecting Path

NOTE: Joints between metal panels and at the interface with masonry are sealed with caulking that appears to be failing in most areas.

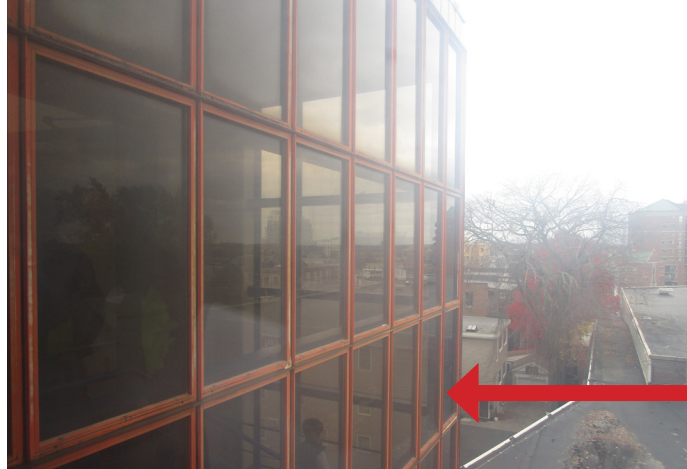
View of stairwell windows in Back Building

NOTE: An extensive window wall covers 1/2 the wall surface of the two primary egress stairs in the back building. Upon visual inspection and review of available documentation, it is not clear that these windows are appropriately fire rated.

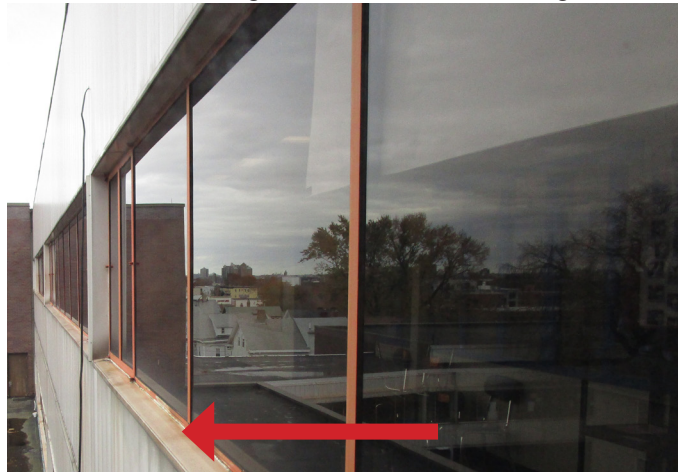
View of windows along North side of Back Building

NOTE: Rusting at window sill

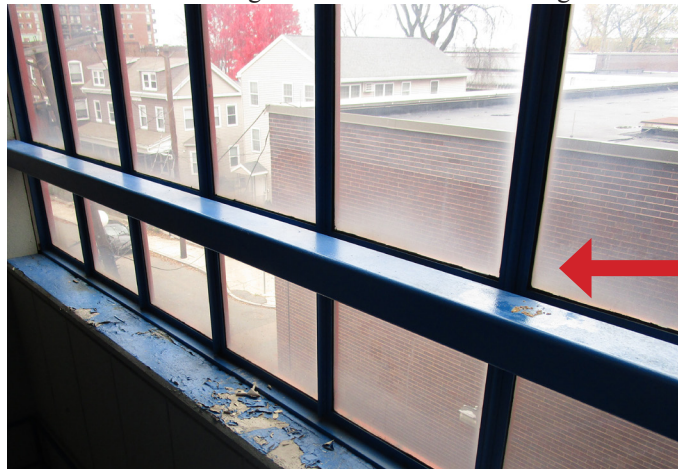
View of windows along North side of Back Building

NOTE: Deterioration at interior window sill and chipping of paint due to both direct water infiltration and condensation due to poor control of humidity and temperature at the perimeter.

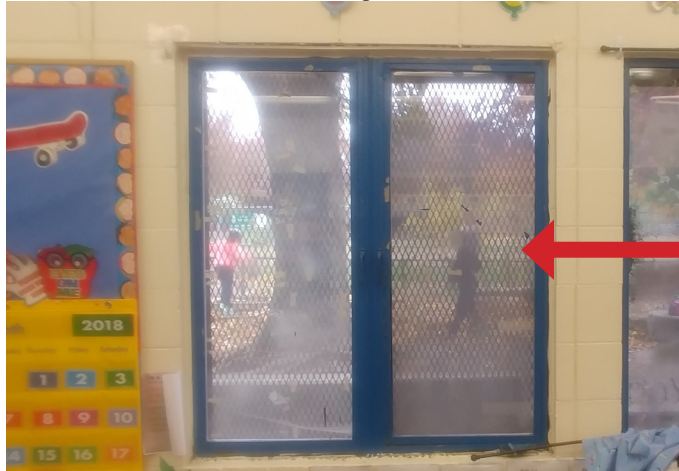
View of window in Back Building

NOTE: Steel Mesh screen used for security at windows in ground floor. Window sealant is failing here in the masonry wall.

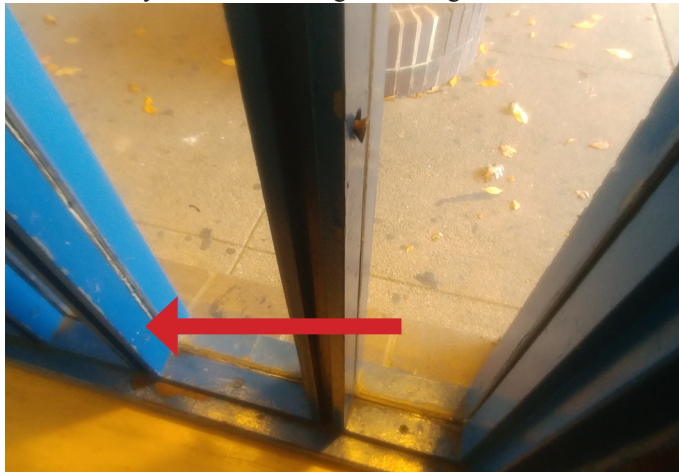
View of Entry of Back Building at Armington Plaza

NOTE: Single pane glazing at entrances without a properly separated vestibule creates paint chipping around windows

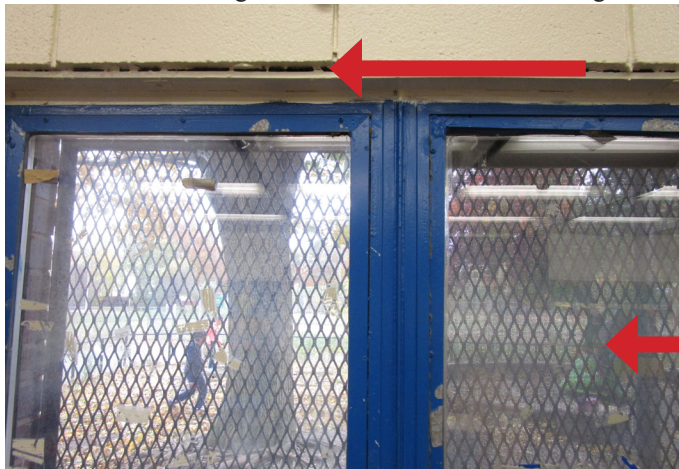
View of window along Southwest side of Back Building

NOTE: Steel Mesh screen used for security at windows in ground floor. Window sealant is failing here in the masonry wall.

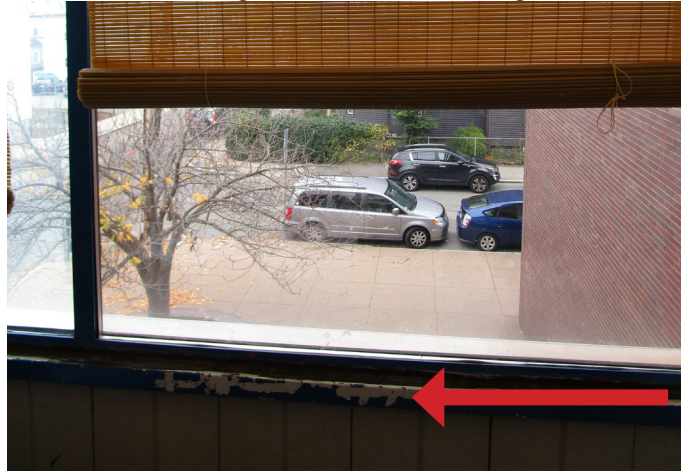
View of window along the East side of the Bridge

NOTE: Paint chipping at window sill

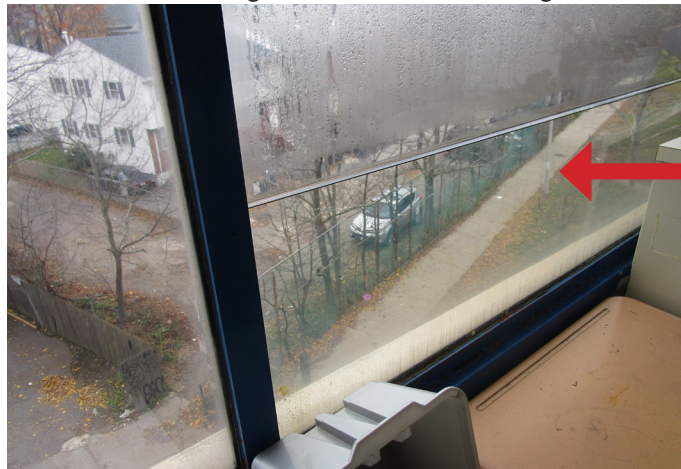
View of windows along East side of Back Building

NOTE: Window with large crack and water in glass

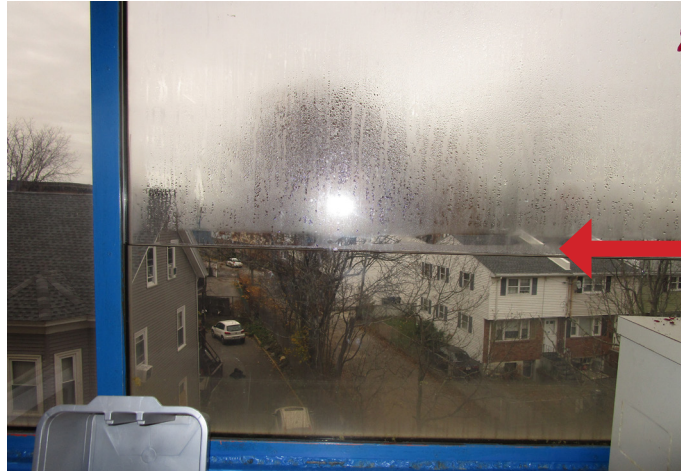
View of windows along East side of Back Building

NOTE: Window with large crack and water in the air space of the insulated glazing unit.

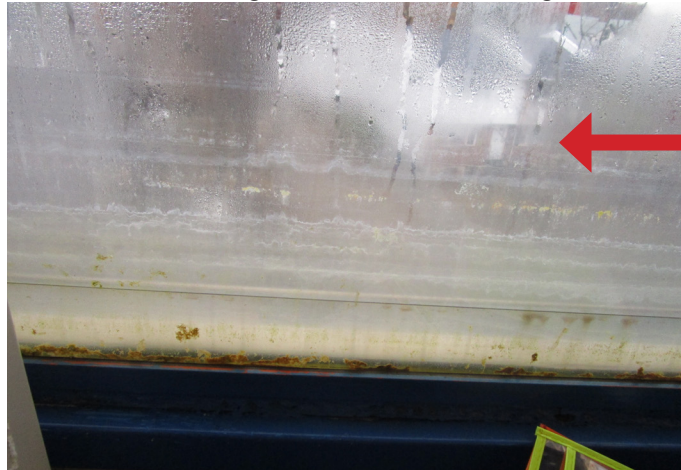
View of windows along East side of Back Building

NOTE: Water damage to window

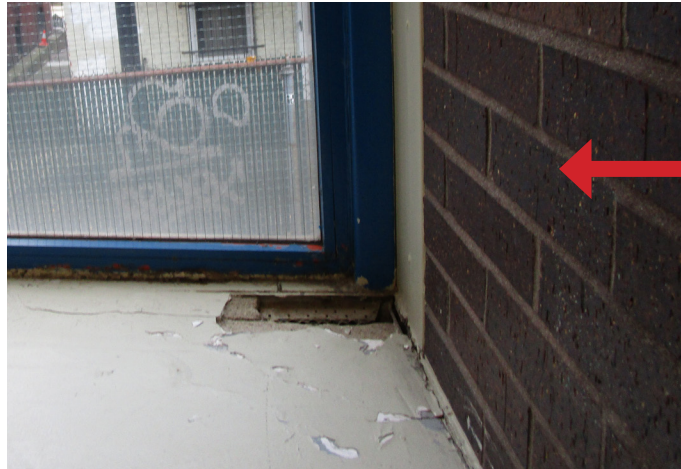
NOTE: View of window with large opening at sill

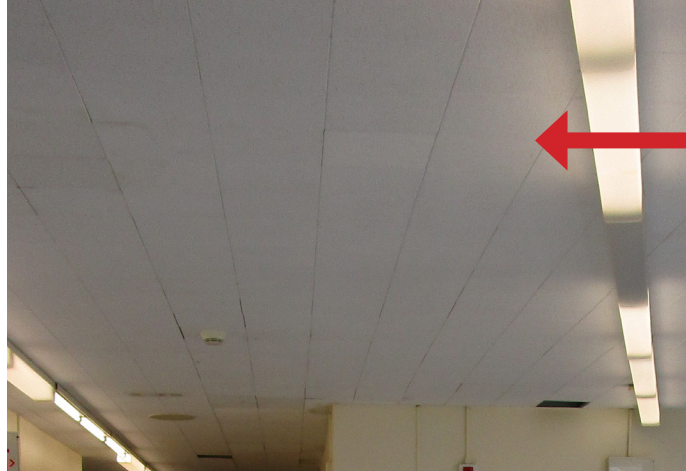
View of 12" x 12" acoustical panel ceiling

NOTE: Acoustical tile ceiling appear to be worn

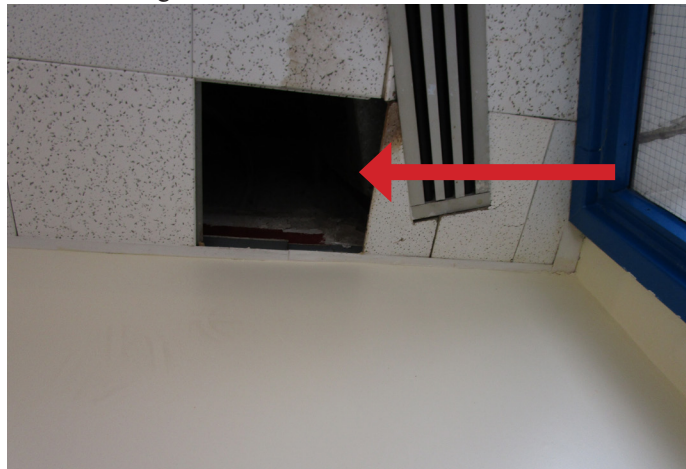
View of ceiling

NOTE: Ceiling panel missing in room

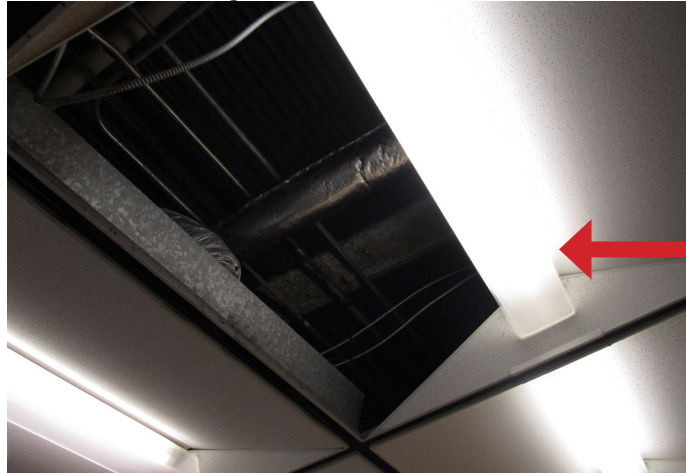
View of coffer ceiling

NOTE: Coffe ceiling panel missing

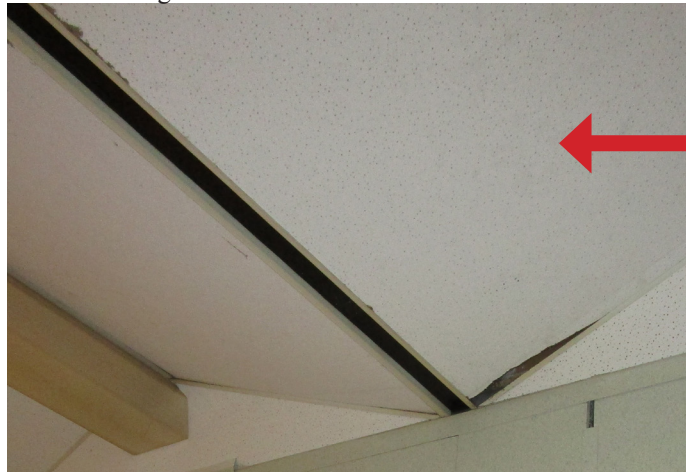
View of ceiling

NOTE: Ceiling panels do not touch and they leave an opening

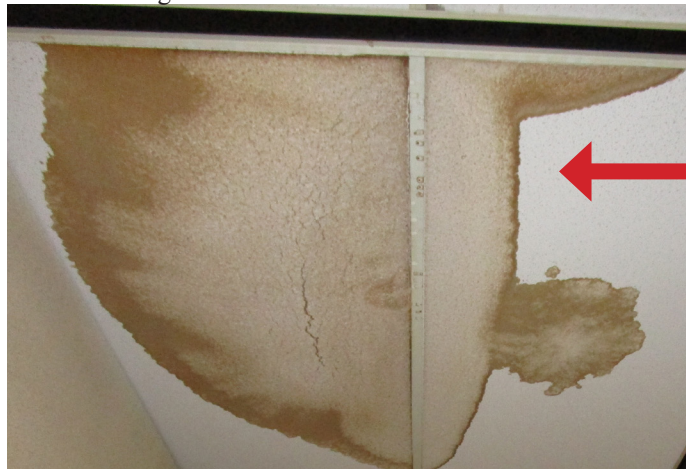
View of ceiling

NOTE: Water damage at ceiling

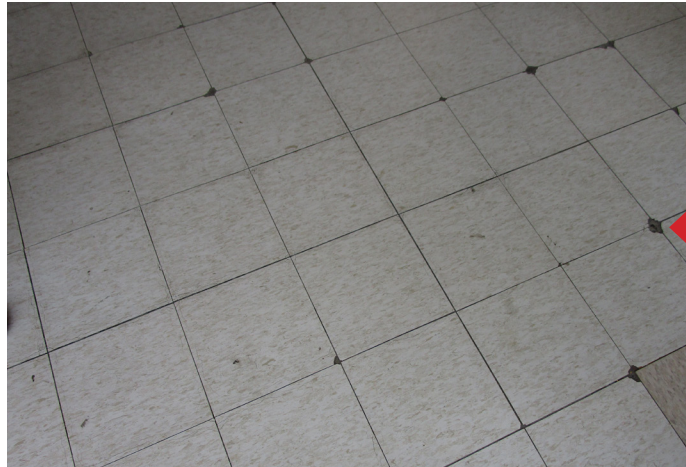
View of tile floor finish

NOTE: Chipping at tile floor

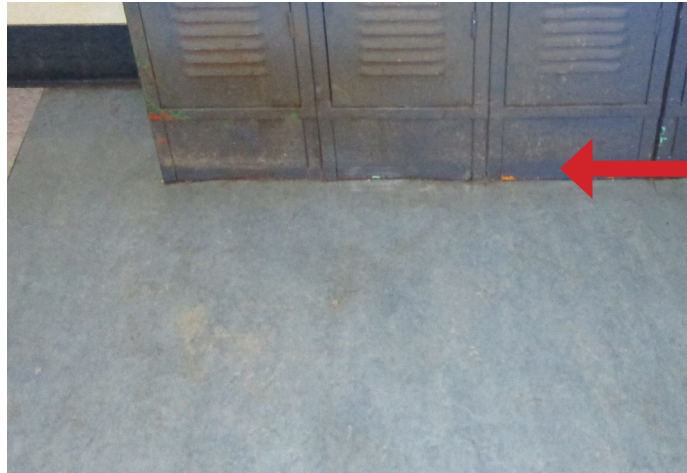
View of floor finish

NOTE: Extremely worn flooring

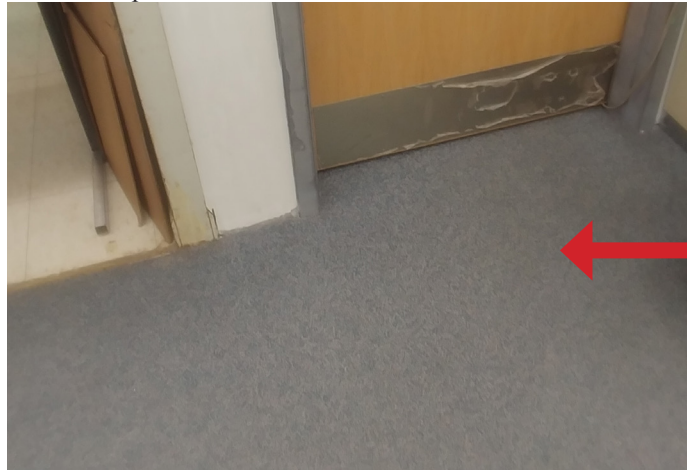
View of carpet floor finish

NOTE: Worn carpet that needs to be replaced

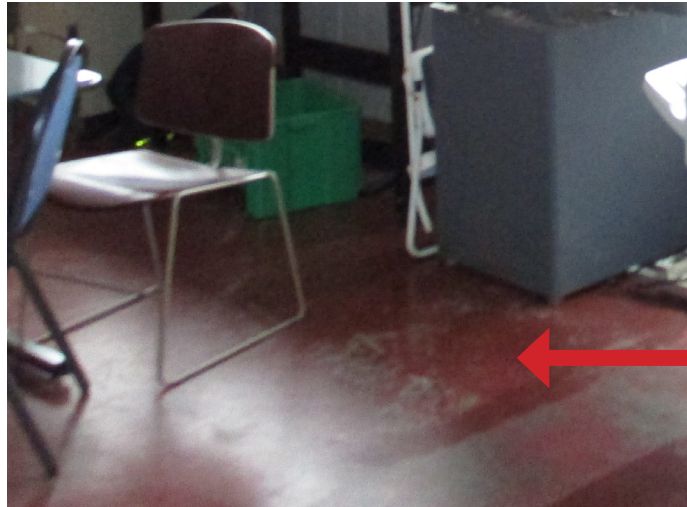
View of floor finish

NOTE: Worn flooring that needs to be replaced

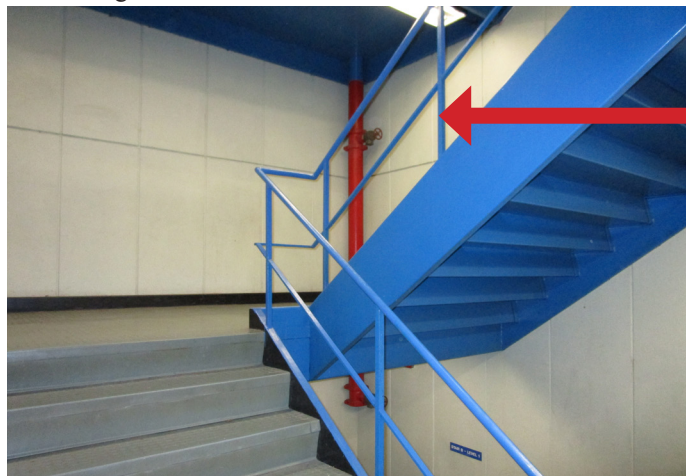
View of Egress Stair

NOTE: Open railings do not conform to current codes.

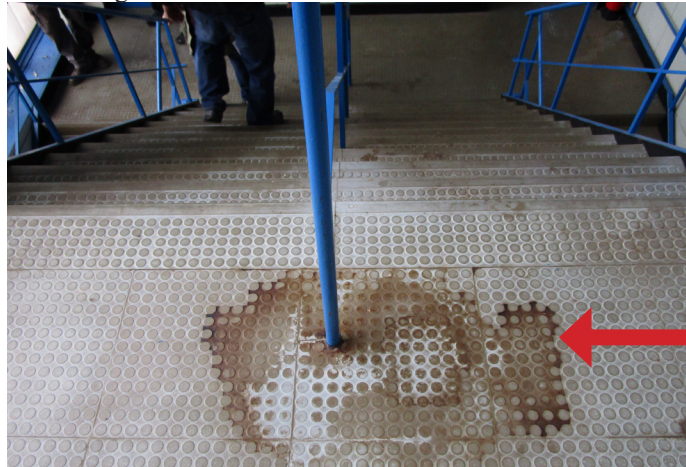
View of Egress Stair

NOTE: Typical wear and tear at egress stair landing

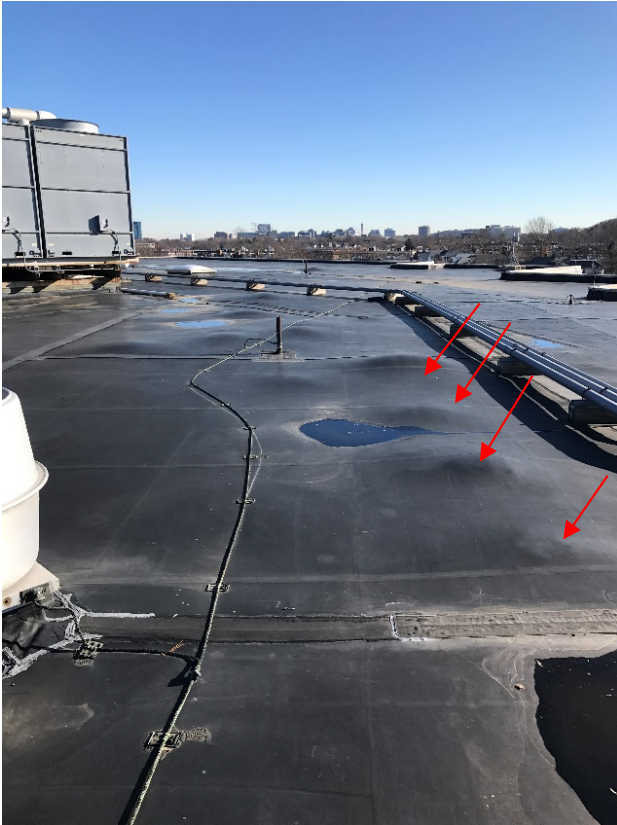
Photo 1

Overview of roofing. Note localized raised areas where the underlying materials are buckled, soft, and deformed (red arrows) and create localized low points where water ponds.

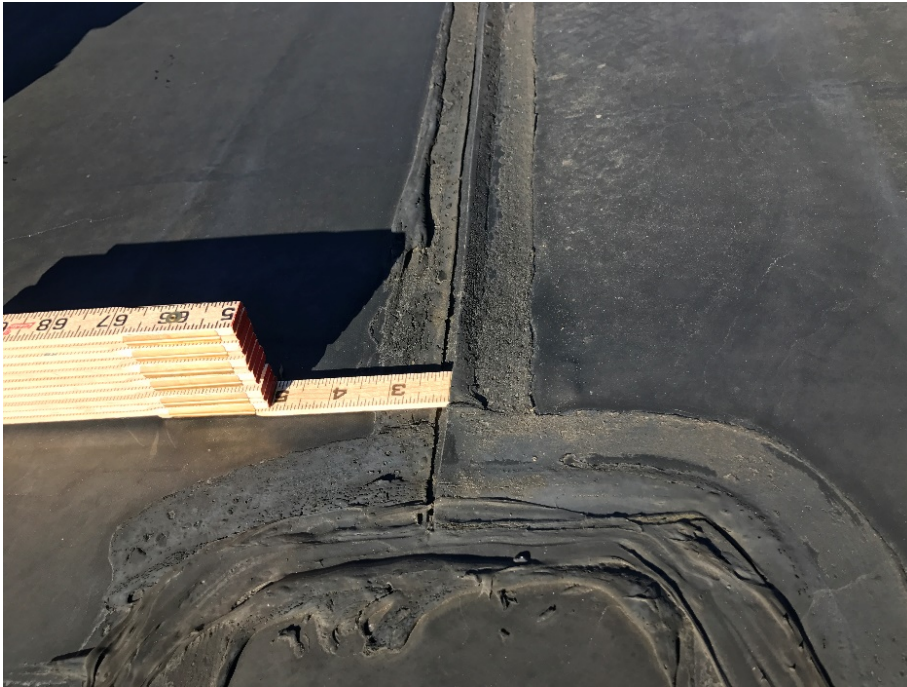
Photo 3

EPDM lap seams are generally unadhered.

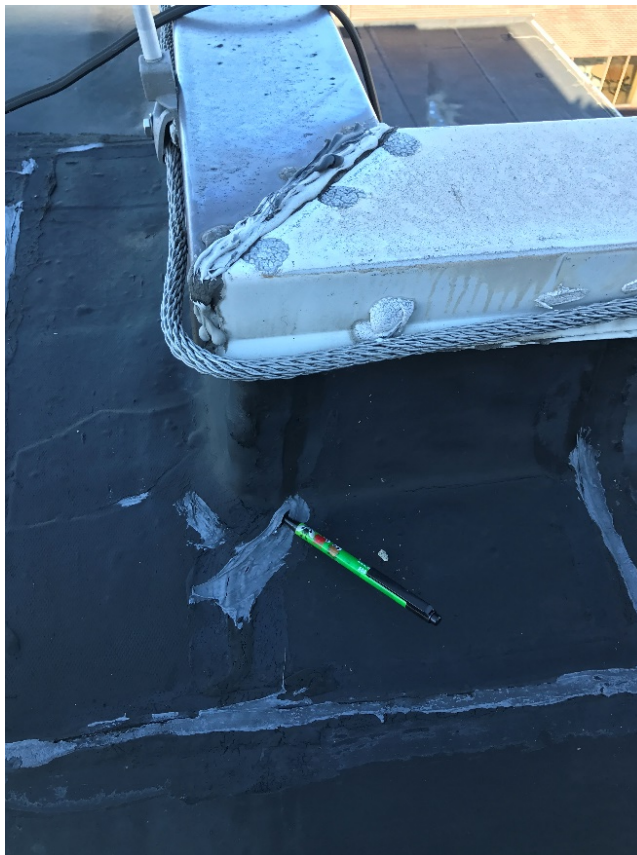
Photo 4

Numerous holes in the field of the EPDM.

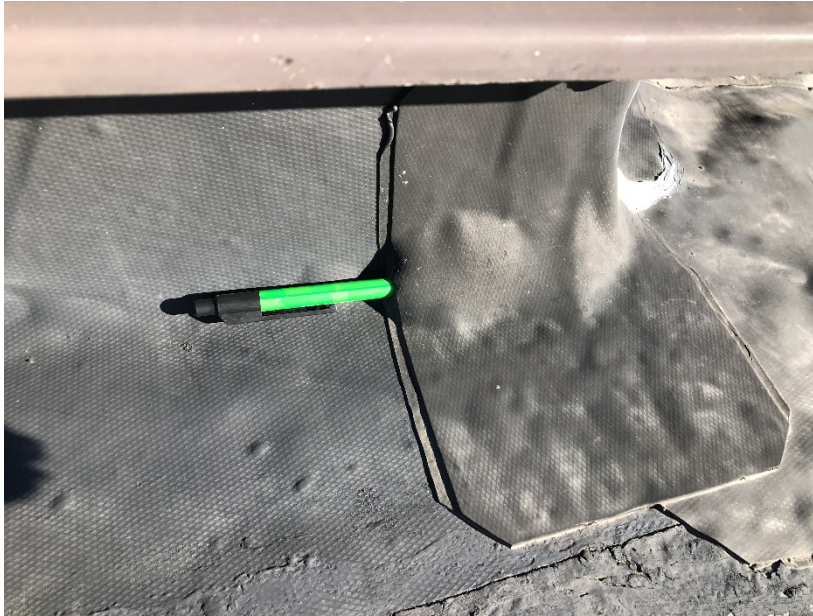
Photo 5

Previous EPDM repair is debonded and bubbled.

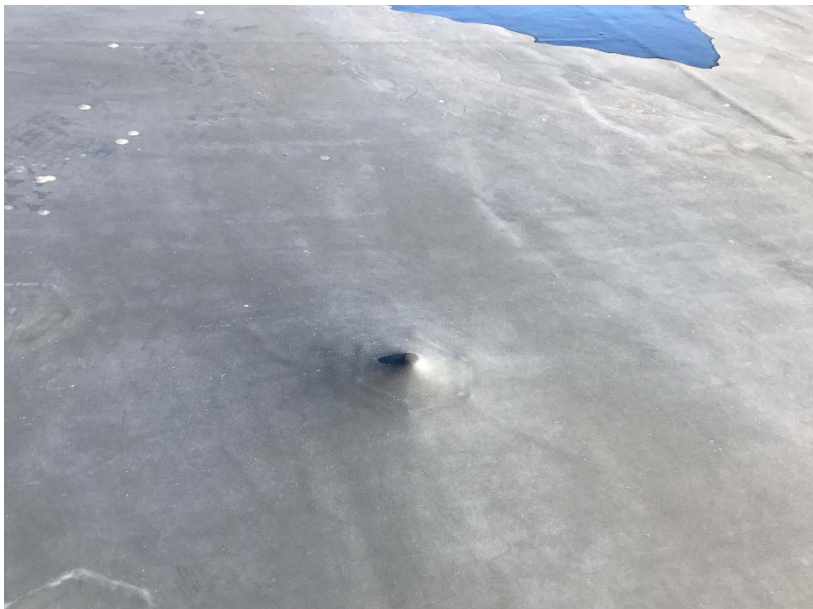
Photo 6

Projecting fastener is visible beneath EPDM.

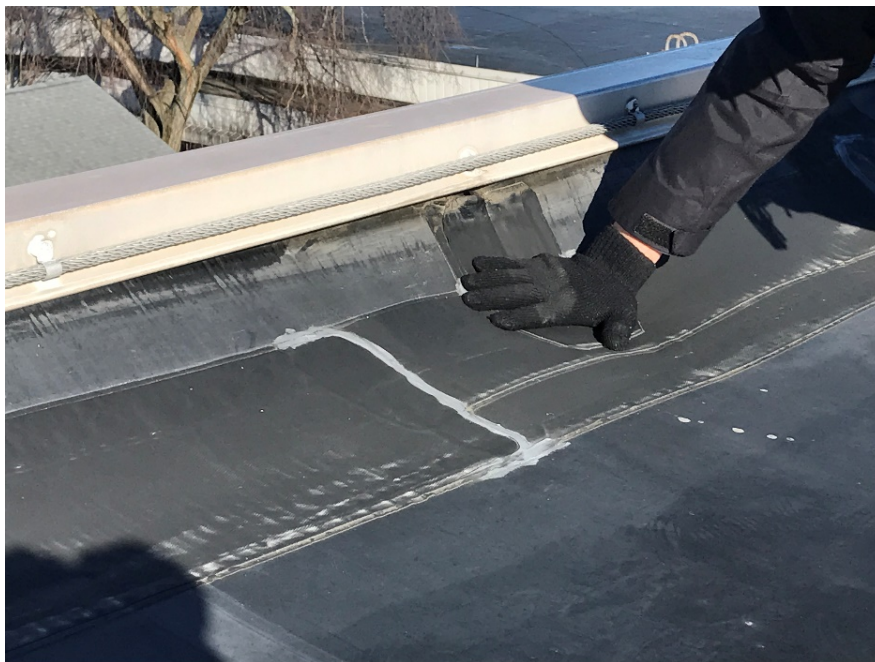
Photo 9

EDPM can be moved by hand and has pulled away from the perimeter coping in some locations.

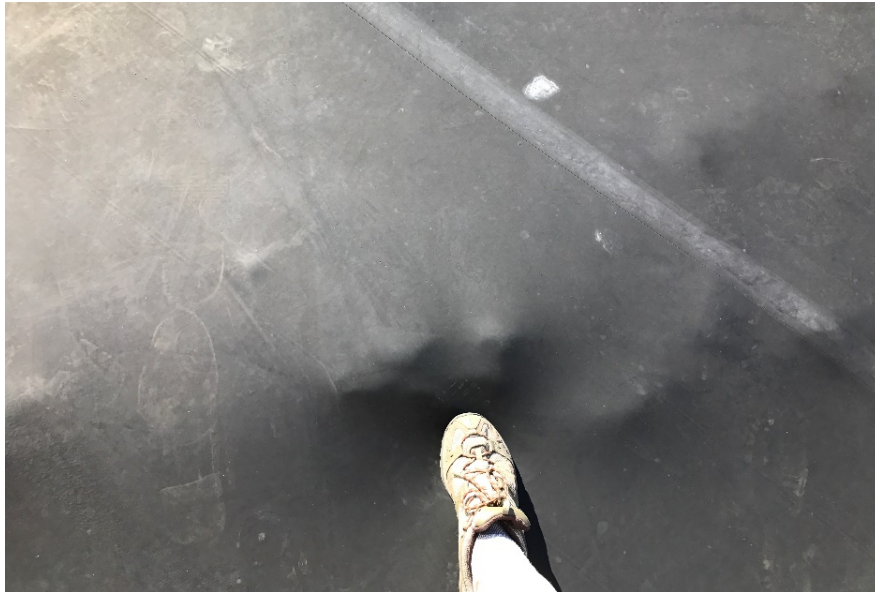
Photo 10

Portions of the buckled/deformed substrate visibly project into the surface of the EPDM.

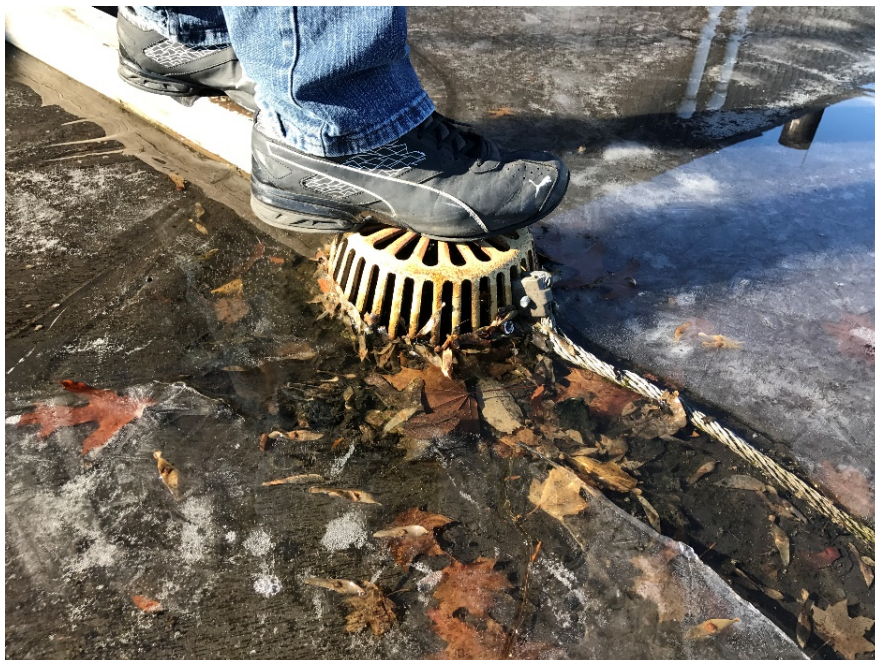
Photo 11

Drain strainers are generally clogged with leaves and debris (note standing water around drain).

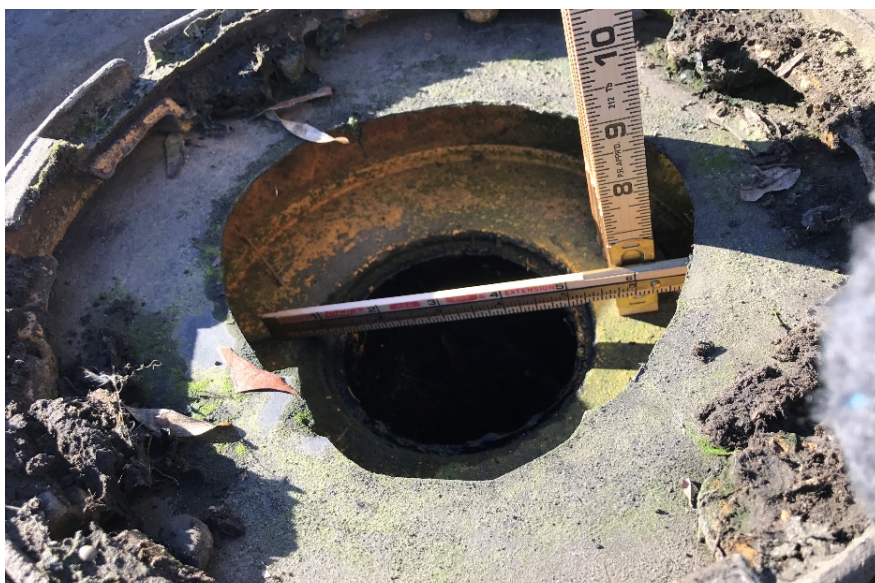
Photo 12

We measured several drains to be about 4 in. diameter.

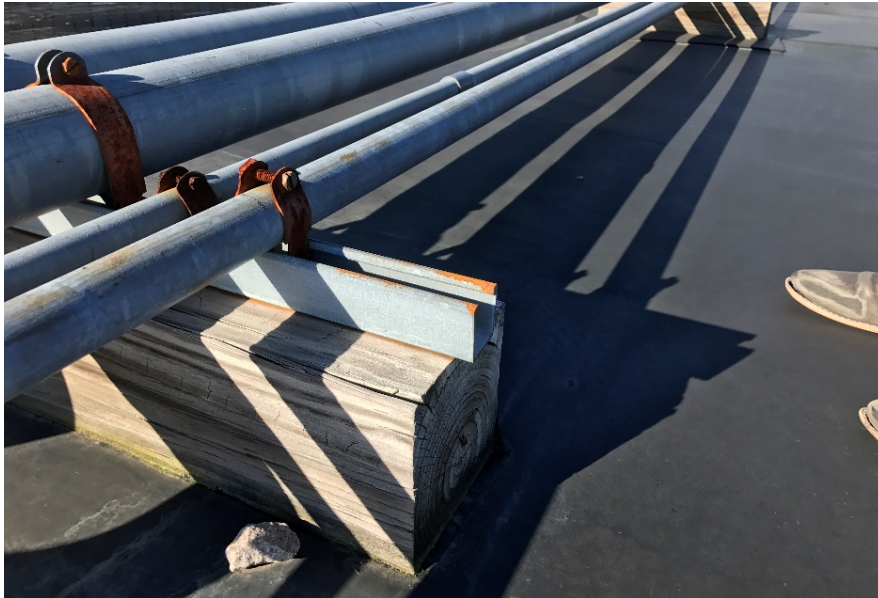
Photo 13

Conduits on wood sleepers that bear directly on the EPDM in some locations (bottom of photo).

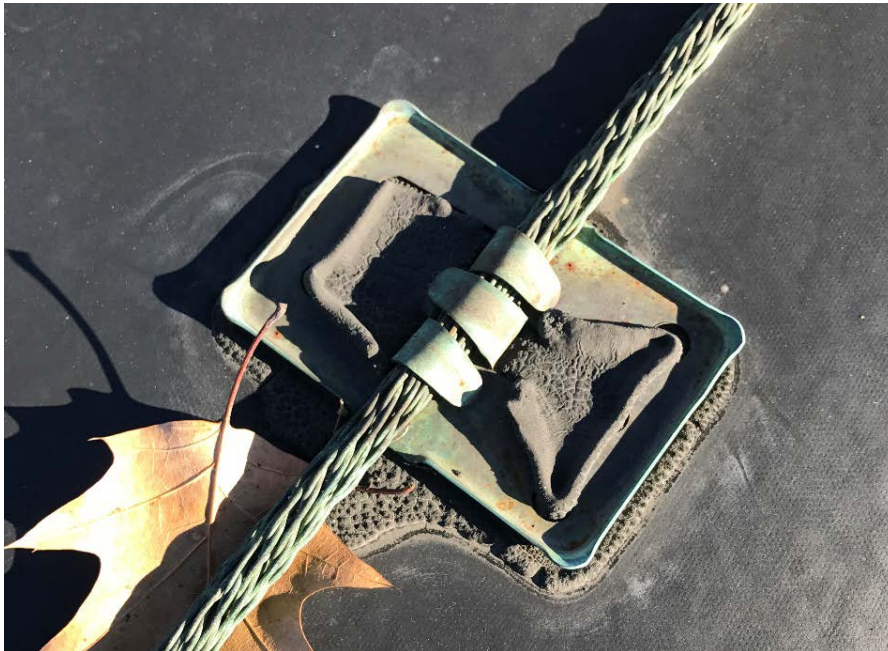
Photo 14

Lightning protection attachments adhered to EPDM.

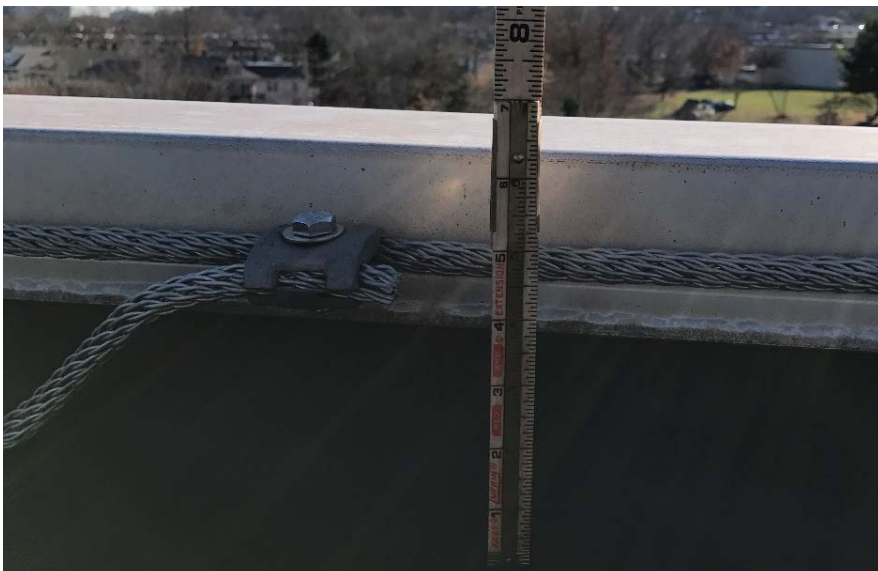
Photo 15

Base flashing heights at perimeter are generally less than 8 in.

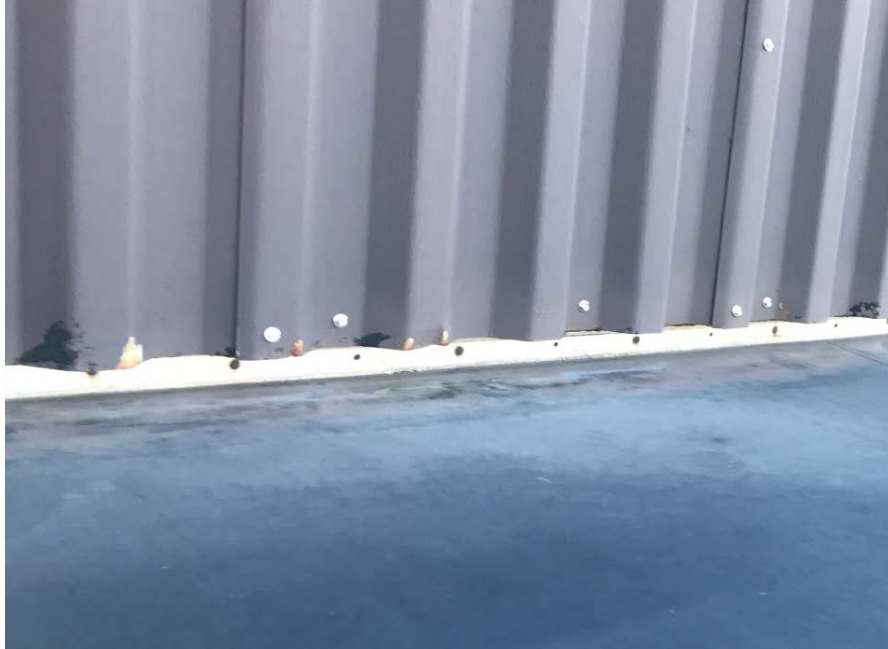
Photo 16

Termination of EPDM at rising walls at the Back Building are typically less than 4 in. above the surface of the membrane.

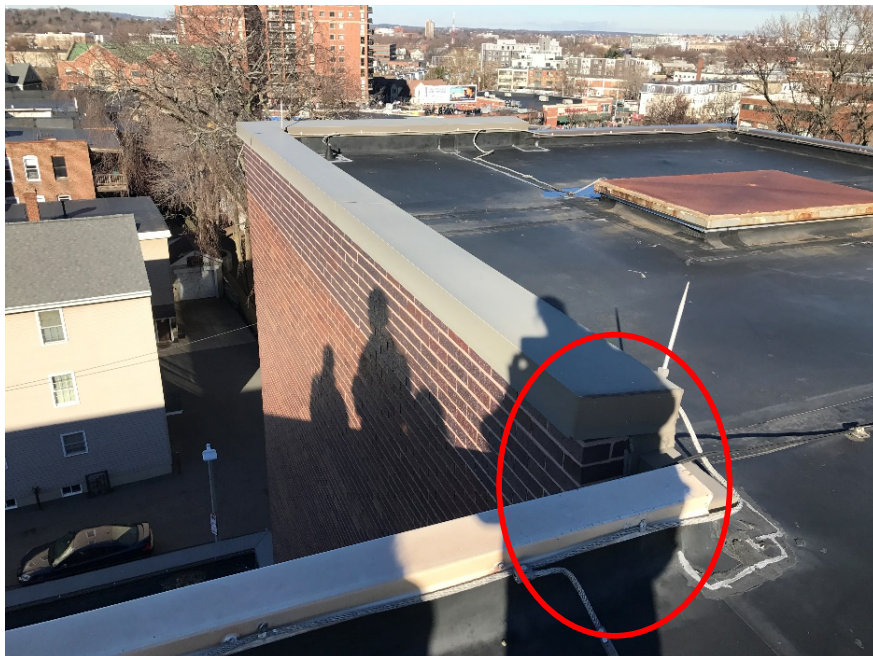
Photo 17

The upper courses of brick at the parapet wall appear to have been rebuilt or constructed more recently than the adjacent brick. Weeps are located at the base of the reconstructed areas. See Photo 18 for a close-up the area indicated in red.

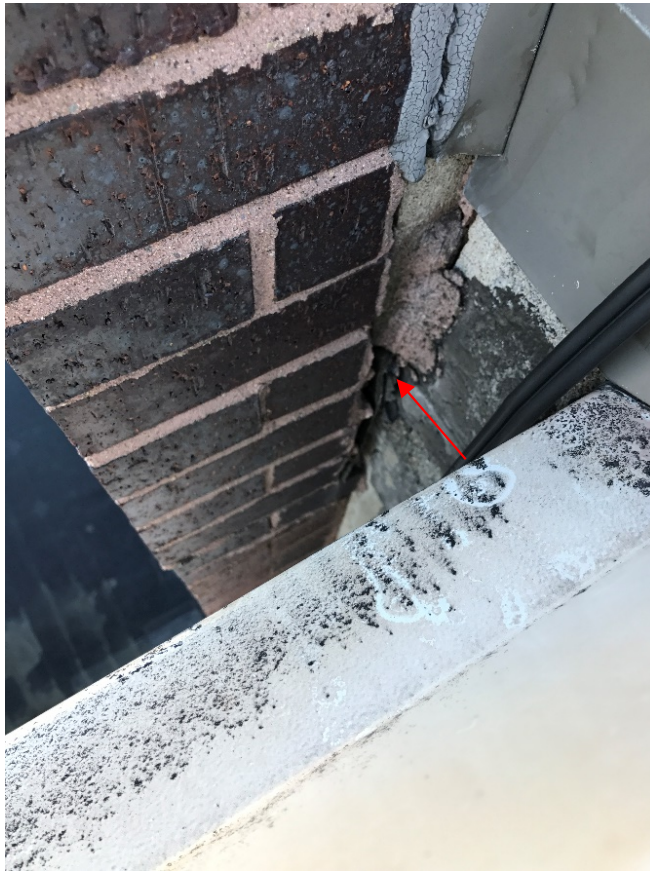
Photo 18

Fabric flashing (red arrow) is visible at the edge of parapet walls that appear to have been partially rebuilt or constructed subsequent to the adjacent brick.

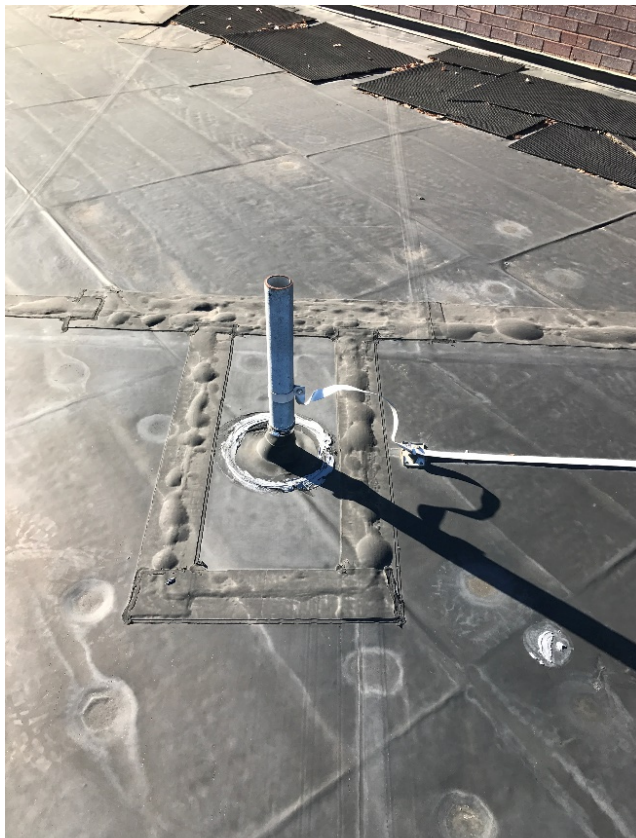
Photo 21

EPDM is bubbled at previous repairs and seam laps.

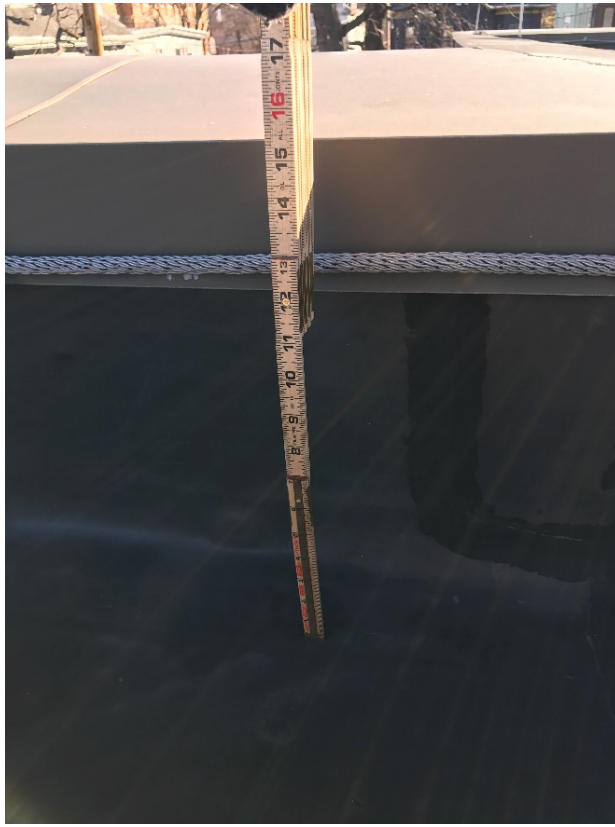
Photo 22

Height of parapet wall and base flashing is more than 8 in.

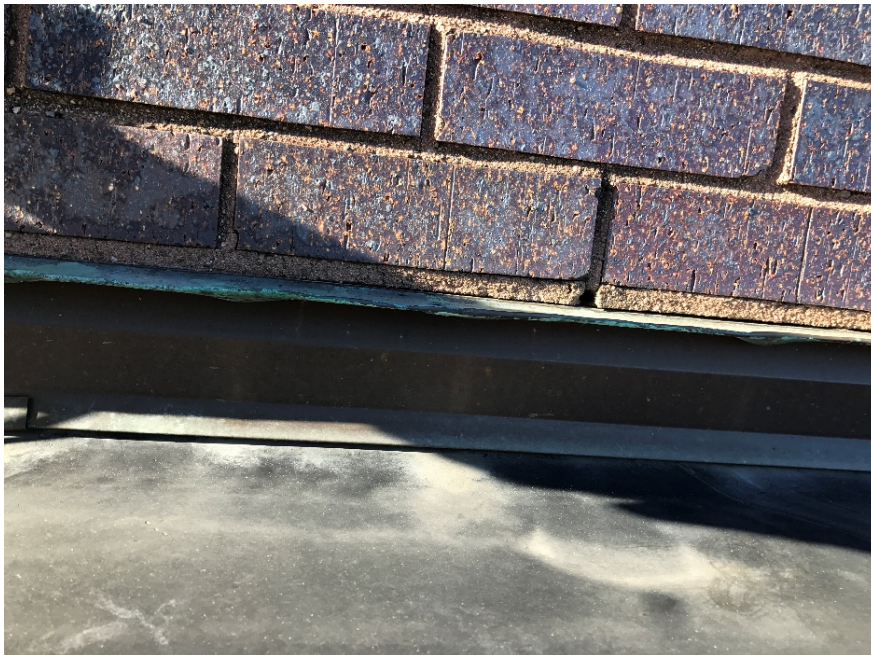
Photo 23

Rising wall terminations are concealed by reglet-set or through-wall copper flashing that is installed beneath older flashing.

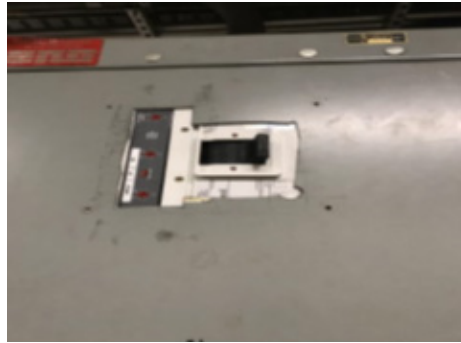
Field modifications made to allow for expansion

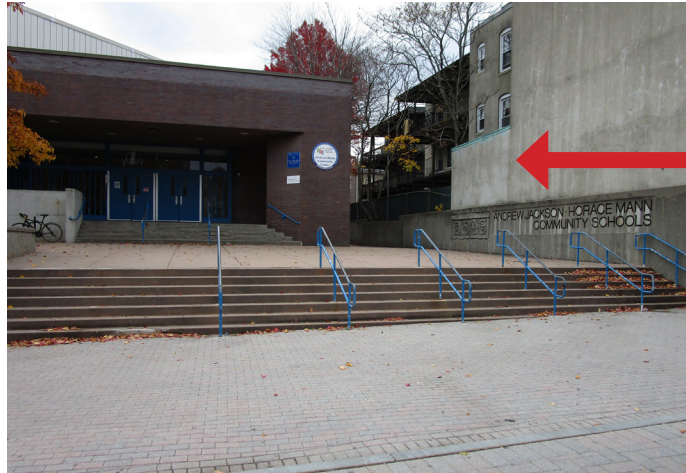
View of Cambridge Plaza

NOTE: Stair and sidewalk interface needs to be fixed
