ANDREW JACKSON/ HORACE MANN SCHOOL CIPR

Date: April 09, 2019

Facility Address: 40 Armington Street, Allston

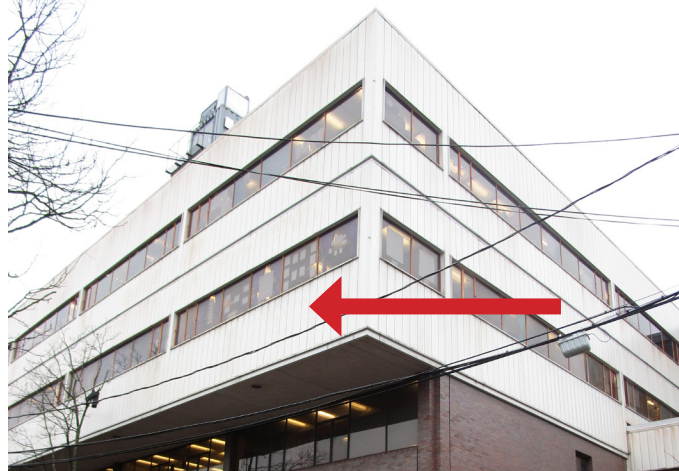
View from East of Bridge

NOTE: The metal panel, apparently now at least partially uninsulated, covers vast portions of the building's exterior. This weak thermal envelope represents a significant burden on the mechanical systems and increases the energy use far beyond current and applicable energy standards.

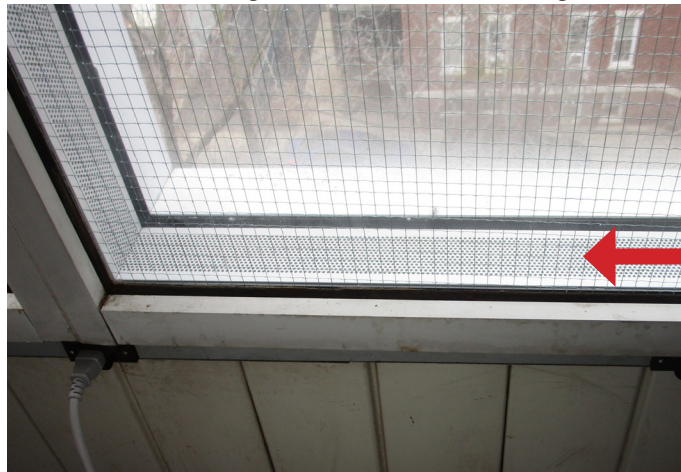
View of windows along North side of Back Building

NOTE: Window with large gap between glass panes and wire mesh

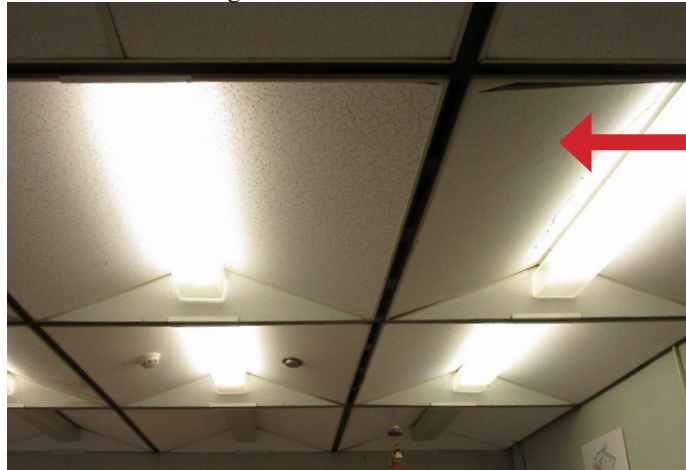
View of coffer ceiling

NOTE: Typical coffer ceiling

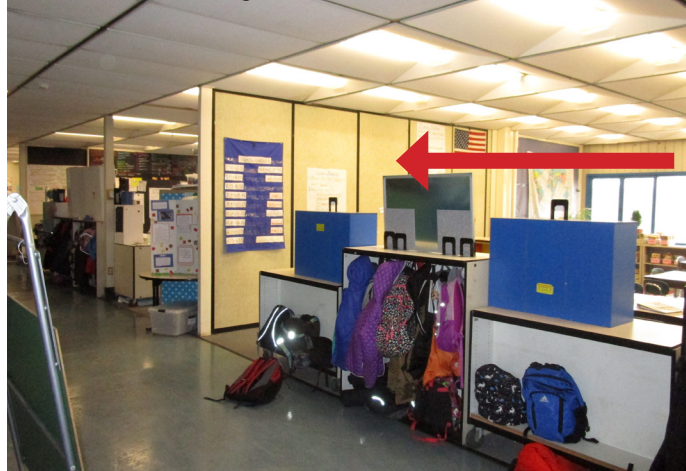
View of demountable partition walls

NOTE: Typical partition wall used to separate classrooms

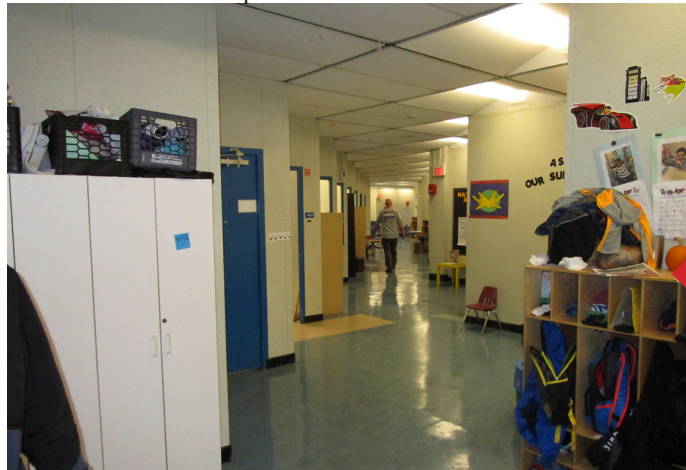
View of demountable partition walls

NOTE: The current partition walls have created cluttered corridors

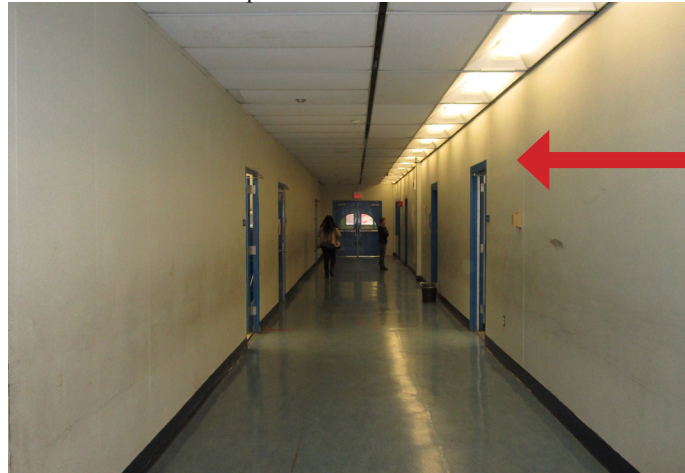
View of other interior partitions.

NOTE: Dull corridor with no natural light

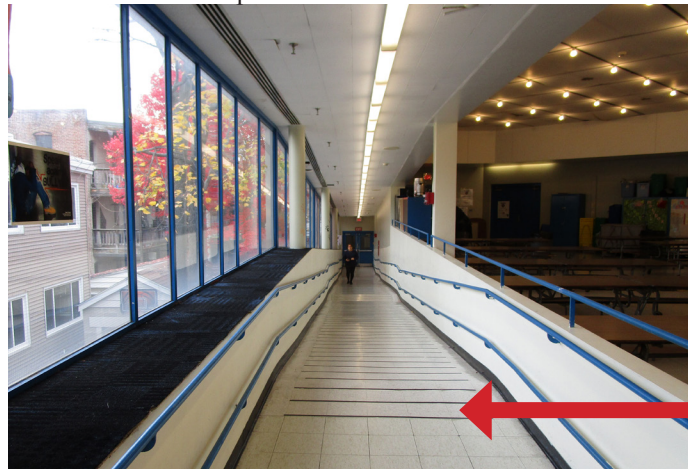
View of Interior Ramp

NOTE: Existing Ramp as seen from the Second Floor.

We recommend extending the ramp into the lobby space. This represents a new length of ramp of approximately 60' in length. The configuration would be the subject of design, but will likely require some form of switchback to fit in the lobby space. This work would require demolition of some existing stairs and the lower landing. We do not think this would require reconstruction of the existing portion of the ramp, but its finishes would need to be updated in keeping with the recommendation for interior finishes previously mentioned.

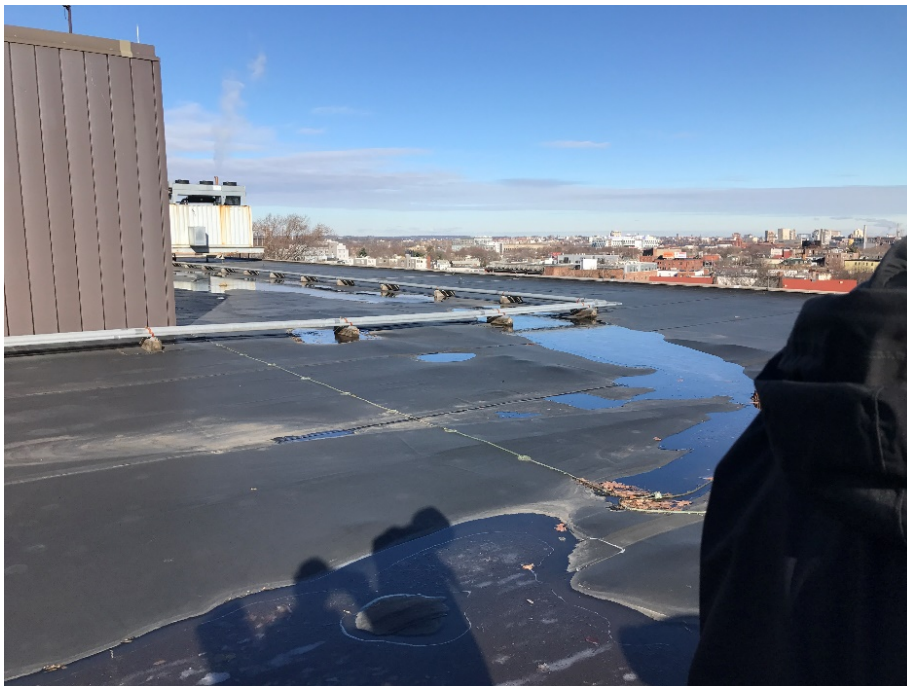
Photo 1

- **Concealed Roofing Materials:** The materials concealed beneath the EPDM are buckled, soft, and deformed (Photos 1 and 10).
 - Deterioration of the underlying materials is evident at the finished surface of the EPDM (i.e., we can hear/feel materials crush under foot pressure, the top surface of the EPDM is mounded and irregular, etc.), which creates localized low points for ponding water (Photo 1).

Overview of roofing. Note localized raised areas where the underlying materials are buckled, soft, and deformed (red arrows) and create localized low points where water ponds.

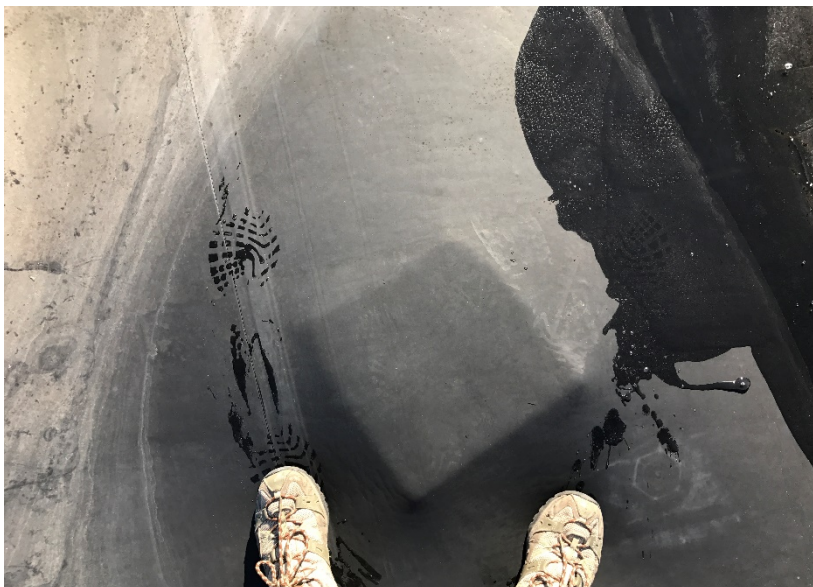
Photo 6

- Previous repairs that are generally debonded, bubbled, or wrinkled (Photo 5).
 - Projecting fasteners and blocking are visible beneath the EPDM (Photos 6 and 7, respectively)

Projecting fastener is visible beneath EPDM.

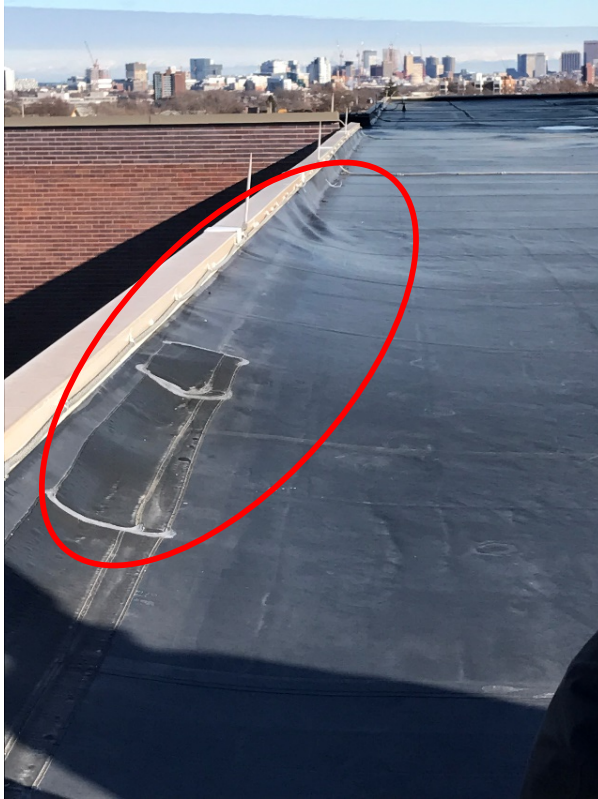
Photo 7

Blocking is visible beneath the EPDM.

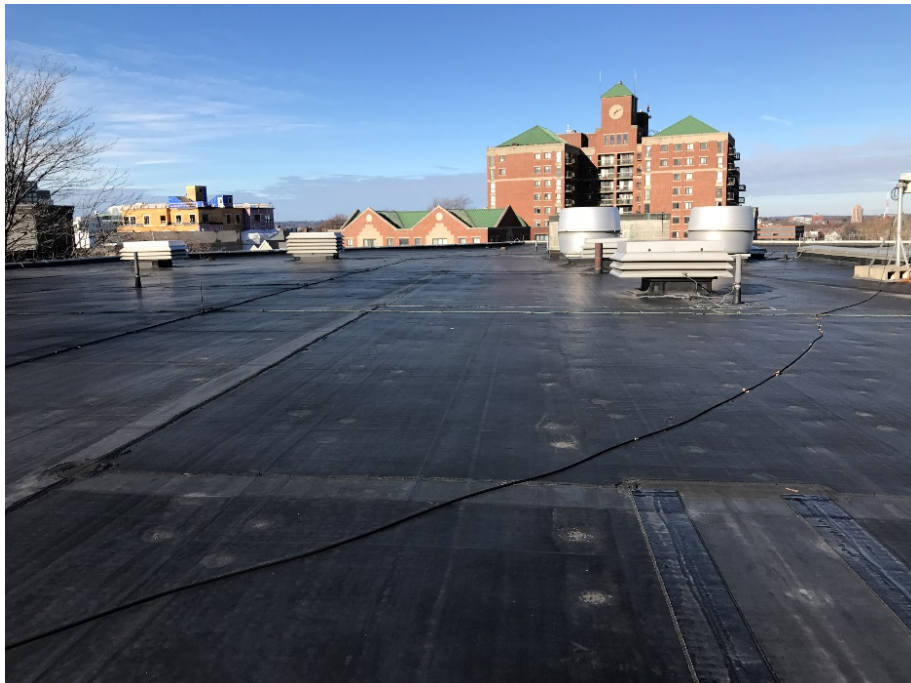
The upper courses of brick at the parapet wall appear to have been rebuilt or constructed more recently than the adjacent brick. Weeps are located at the base of the reconstructed areas. See Photo 18 for a close-up the area indicated in red.

Fabric flashing (red arrow) is visible at the edge of parapet walls that appear to have been partially rebuilt or constructed subsequent to the adjacent brick.

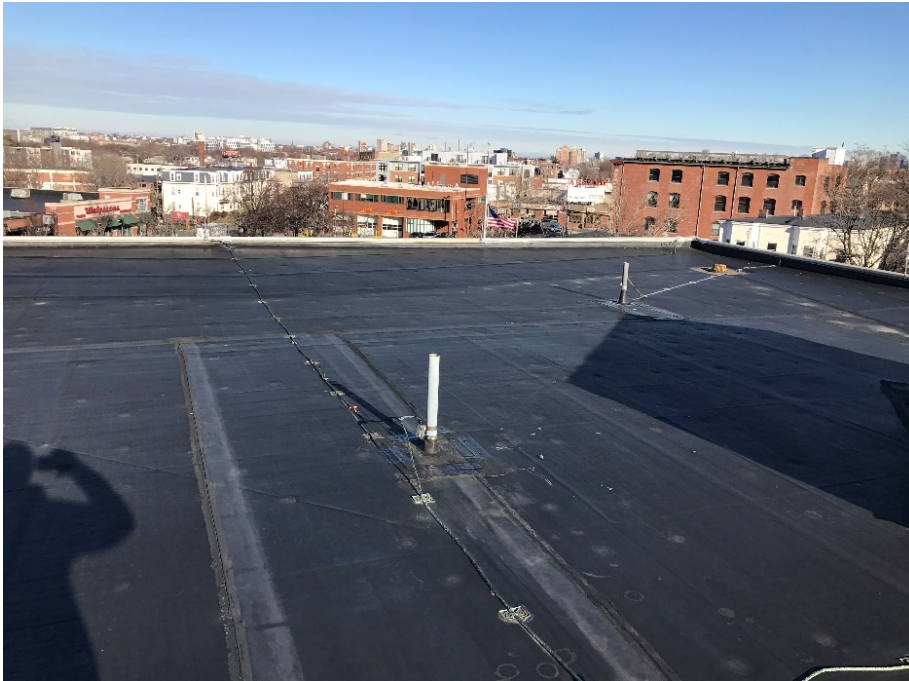
Photo 19

We observed similar roofing conditions at the Front Building (e.g., unadhered EPDM, open lap seams, repairs that are bubbled/failed, holes in the membrane, etc.) (Photos 19 – 21) and stamps that indicate the EPDM is contemporary with that at the Back Building (i.e., about 25 yrs old). However, we observed the following roofing conditions to be less severe than that of the Back Building:

- Little to no water is ponded on the roof, likely due in part to visible crickets and slope to drain with more-closely-spaced roof drains (Photos 19 and 20)
- The base flashing heights at the Front Building are generally more than 8 in. above the roof surface at rising walls and perimeter copings (Photo 22).
- Rising wall terminations are concealed by a metal counterflashing that is in good condition and is installed beneath older flashing (Photo 23).
- Fewer roof penetrations and less mechanical equipment.

Overview of roofing.

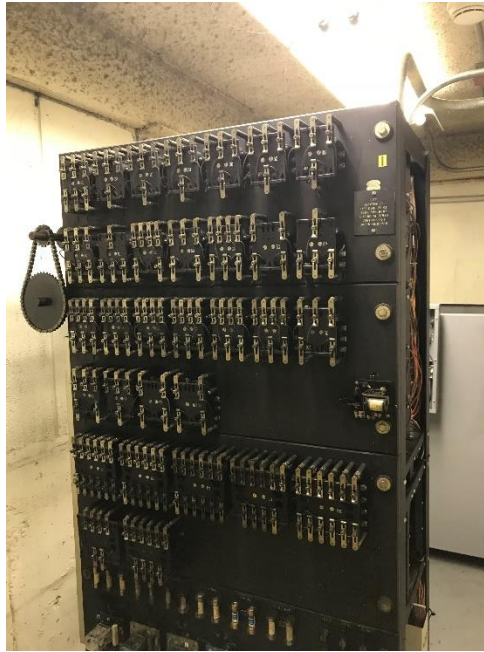
EXISTING RELAY LOGIC CONTROL SYSTEM

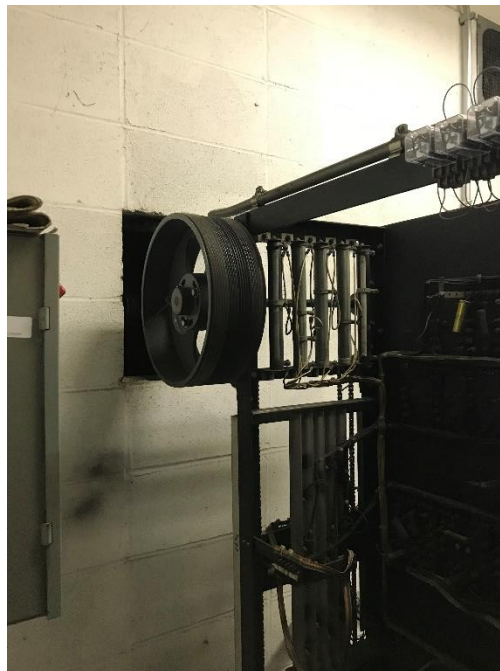
EXISTING FLOOR SELECTOR SYSTEM

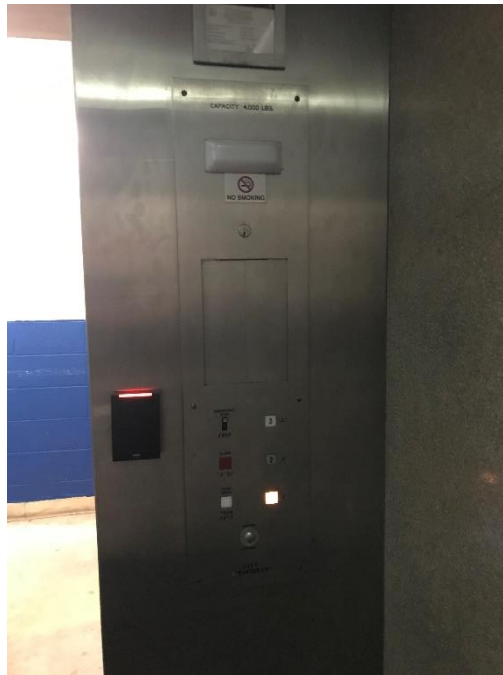
EXISTING CAR OPERATING PANEL

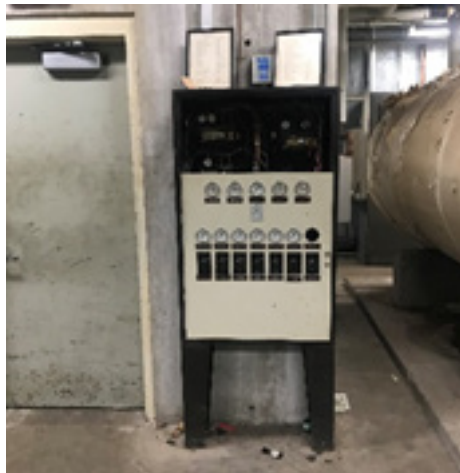
Existing Pneumatic Control

All new automatic temperature controls shall be direct digital type with dynamic controls with remote read/adjustment and alarming capabilities.

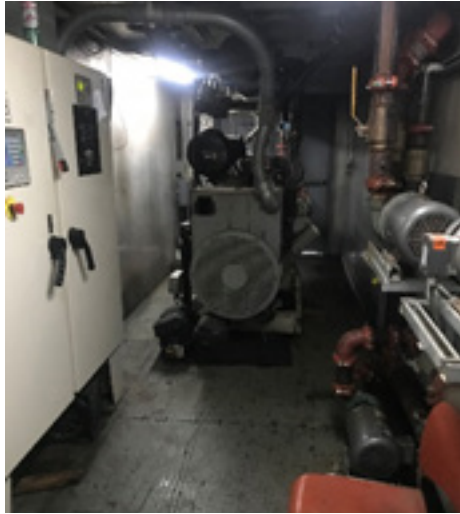
Existing Cogeneration Unit

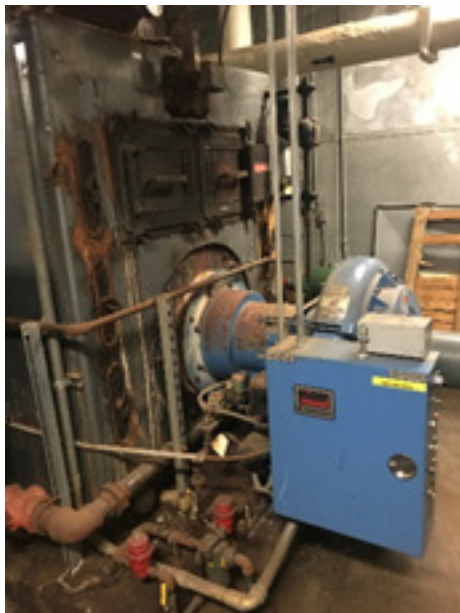
Existing Gas Fired Boiler

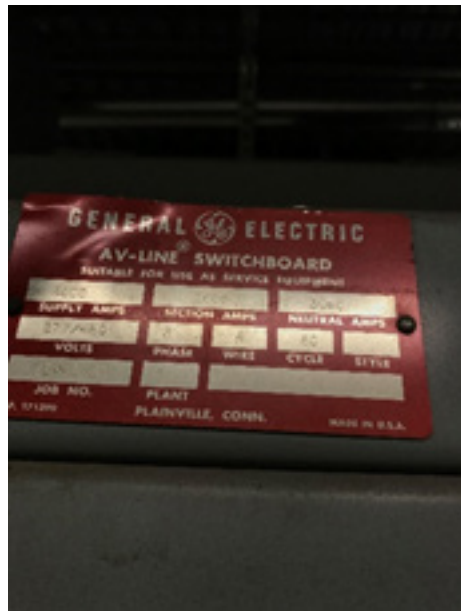
Switchgear nameplate rating

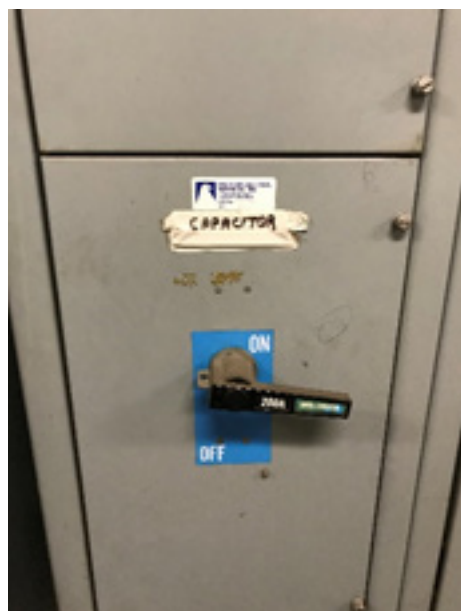
Typical switch within the main switchboard

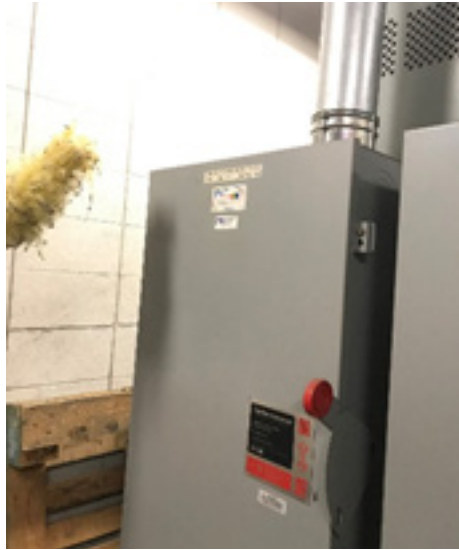
Typical switch within the main switchboard

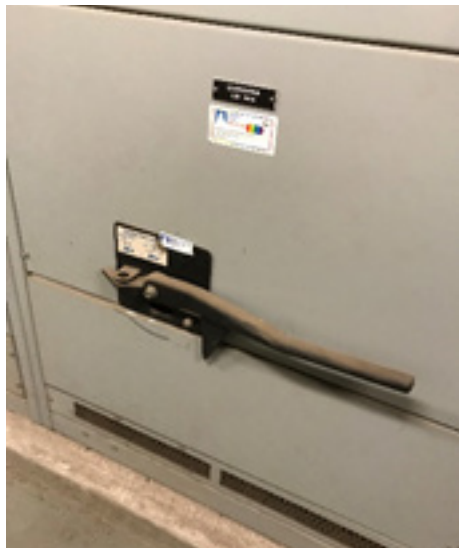
3000A Main disconnect bolted pressure switch

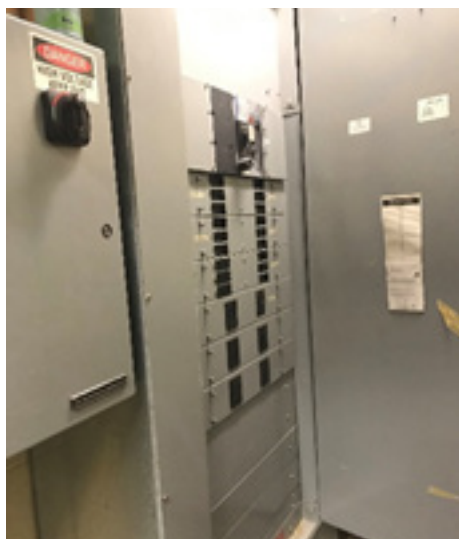
New panel added to accommodate HVAC and technology needs

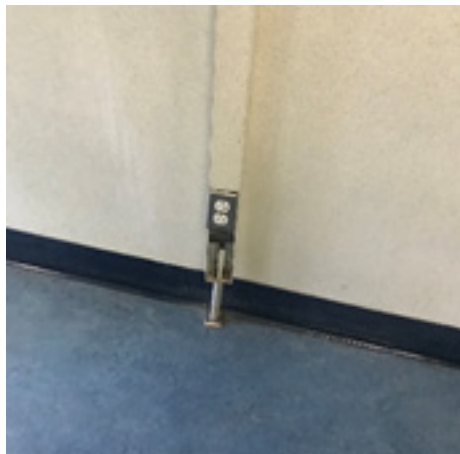
A large portion of the building interior walls are modular type construction, as part of an overall wall and distribution system the wiring is fed down from the ceiling through dedicated wireways at the wall seams. In many cases these dedicated wireways have begun to fail and have detached from its associated wall.

Wireway system in disrepair

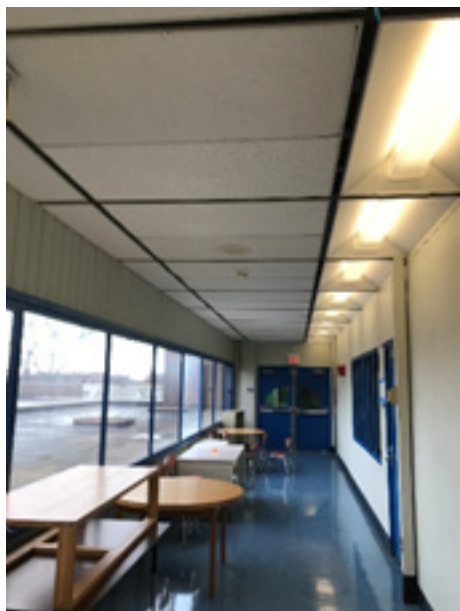
Wireway on right side of hall detaching from wall behind it

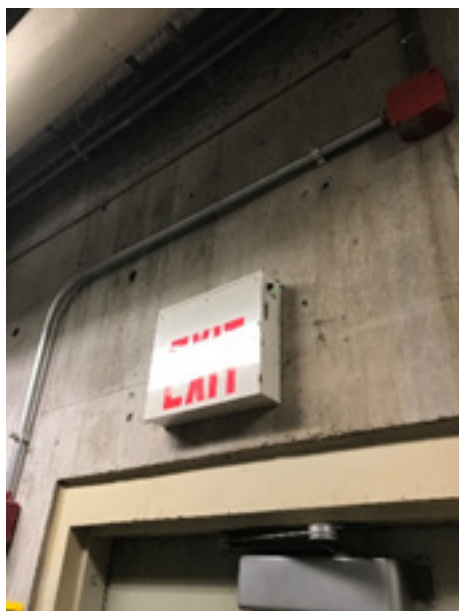
In most cases, lighting fixtures are controlled via wall toggle switches, and in some cases ceiling mounted occupancy sensors (mostly in corridors). Emergency lighting is fed from the emergency generator and has been supplemented by battery units with dual heads in select areas. Exit signage also appears to be fed from the emergency generator, but many more supplemental battery backup exit signs were observed.

Battery back-up exit sign

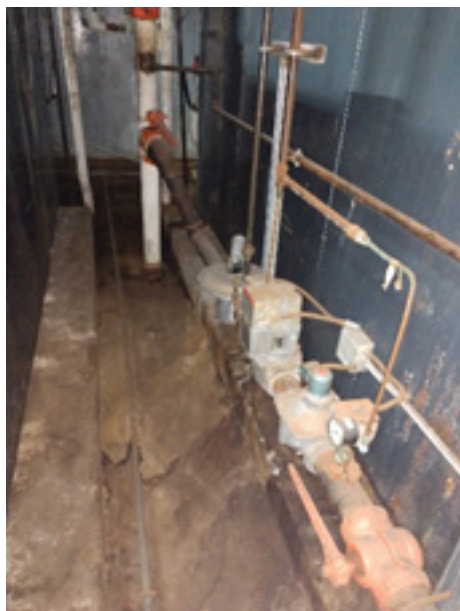
Boiler Gas Train

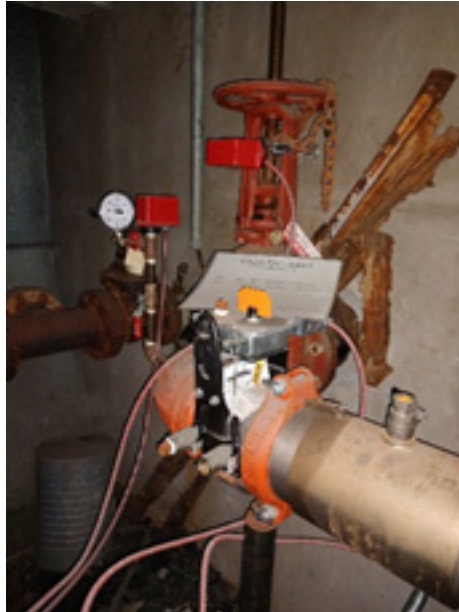
NOTE: Existing 6" fire service main entrance

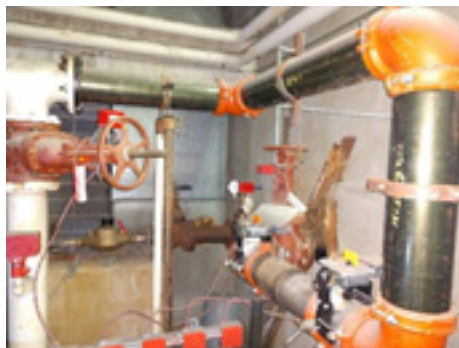
NOTE: Existing 6" fire service backflow preventer

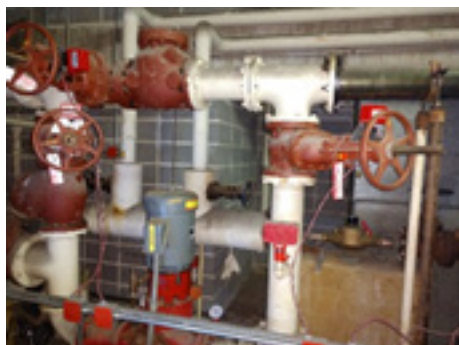
NOTE: Existing fire Pump

The system shall be inspected internally in order to determine the system piping corrosion status. The existing sprinkler heads are approaching the 50 year testing requirement, per NFPA 25, Standard for Inspection, Testing and Maintenance of Water-Based Fire Protection Systems. Based on the current sprinkler head count it shall be considered to be completely replaced with a new quick response sprinkler heads and possibly extend the sprinkler coverage for the entire building throughout. Upon completion of the internal obstruction investigation it will be determined if the entire existing system would need to be replaced or reconfigured to accommodate the complete sprinkler coverage throughout. Based on new hydraulic calculations, it shall be determined if the existing fire pump is still required or if it can be completely removed. If the hydraulic calculations prove the

need of the fire pump, Boston Fire Prevention shall be consulted with regards to the use of the existing limited-service controller as it is mandated by NFPA 20, Standard for Installation of Stationary Pumps for Fire Protection.

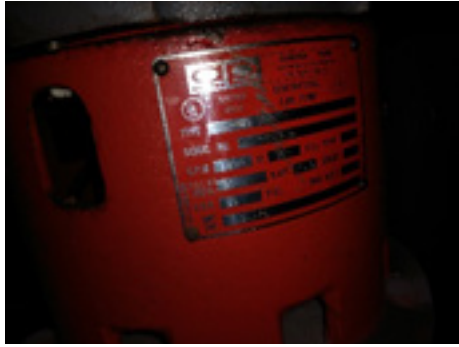
NOTE: Fire Pump

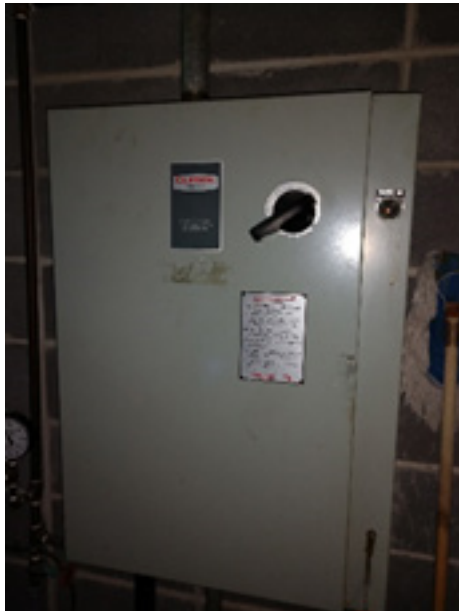
NOTE: Fire Pump Controller

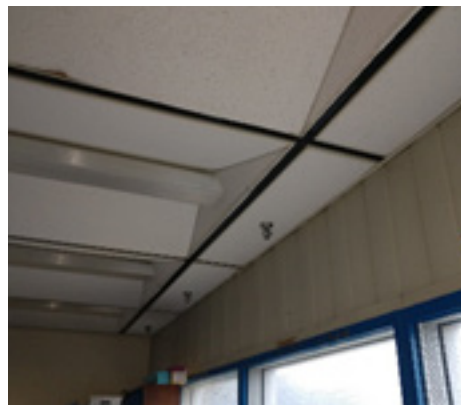
NOTE: Sprinkler heads

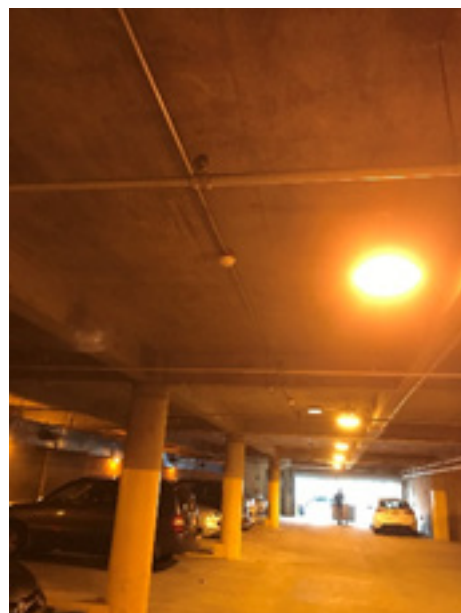
NOTE: Sprinkler heads in garage

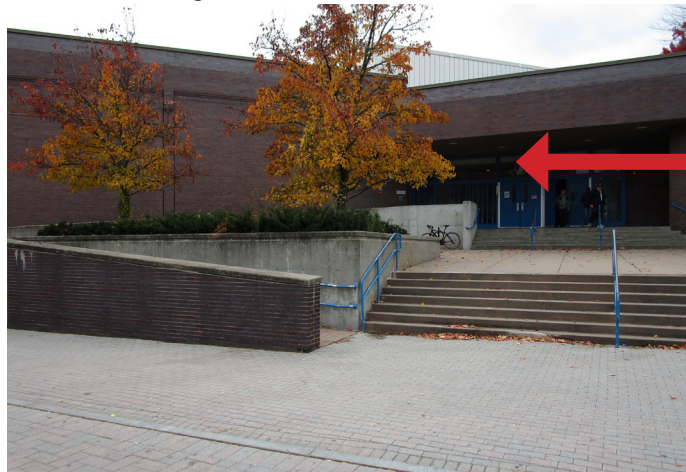
View of Cambridge Plaza

NOTE: Stair and sidewalk interface needs to be fixed

We recommend minor upgrades to the Cambridge Street Entry Plaza to improve both accessibility and to create a more welcoming image to the School. This would include fixing the stair interface with the sidewalk, minor landscape improvements and adjustments to the ramp. Recommend providing a \$50,000 allowance for this work.

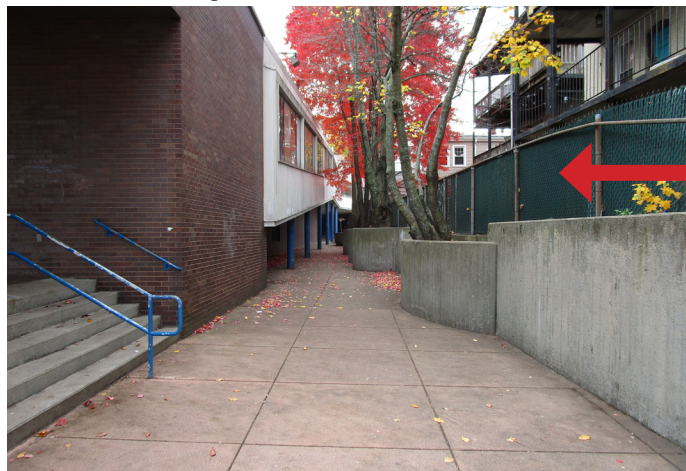
View of Connecting Plaza

NOTE: Ramp and landscaping additions could make entry more welcoming

We recommend redesigning this link to be a safer, pedestrian friendly and more inviting connection between Cambridge Street and Armington Street. Work would include eliminating the dark corner under the lower portion of the bridge by pulling out the perimeter of the building. Additional work would include landscape, materials, benches, lighting and wayfinding. We recommend providing a \$50,000 allowance for this work.

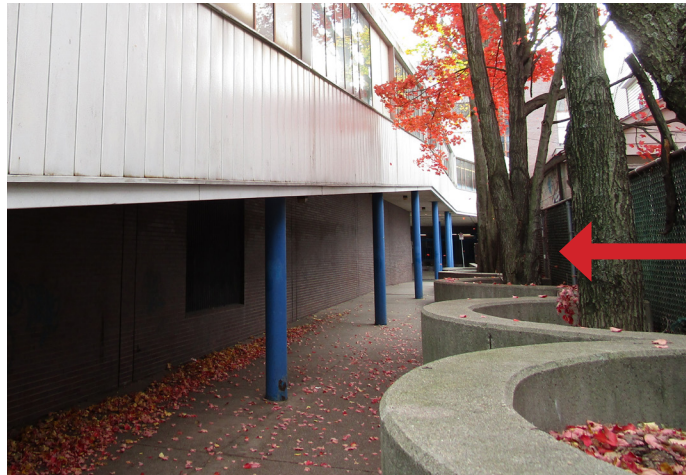
View of Connecting Plaza

NOTE: Lighting and wayfinding would help create a friendlier and more functional environment

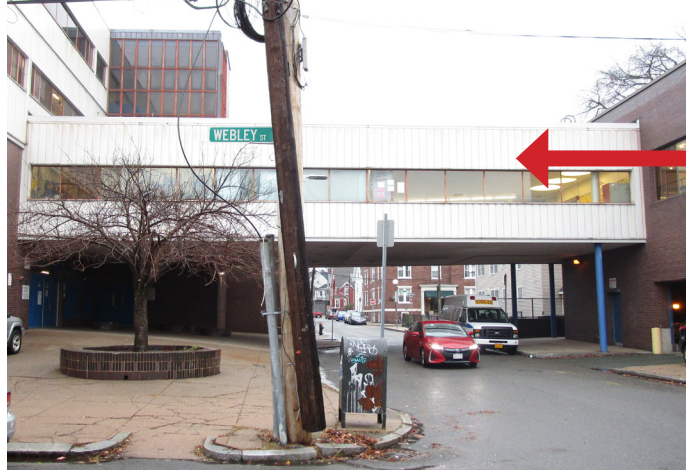
View of Armington St. Plaza

NOTE: Pulling the building surface under the bridge forward would create a safer environment

We recommend redesigning this important entry plaza to drastically improve ADA accessibility and usefulness for student drop off and pick-up. This work would include full regrading and all new pavers with the ramps and stairs that may be required. Additional work will include some green landscaping and ample lighting under the bridge.

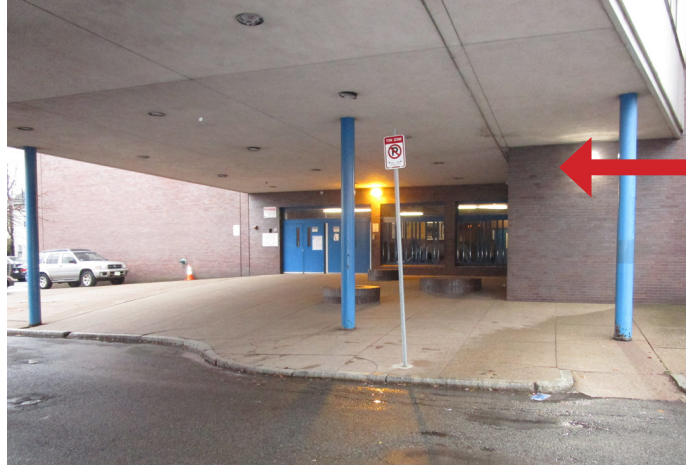
View of Armington St. Plaza

NOTE: The entry into the Back Building appears very dark, needs additional lighting

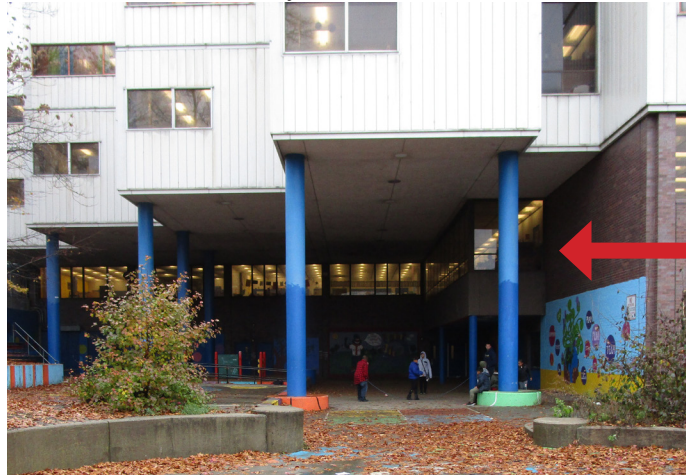
View of Rear Covered Play Area

NOTE: The entry into the Back Building needs a new ADA compliant ramp and a new paving system

We recommend a complete replacement of the play area underneath the south portion of the building. This space could be dramatically improved, in terms of accessibility, safety and overall child enjoyment, by new play surface, custom playground equipment that takes advantage of the building (i.e., a slide wrapping a structural column) and the introduction of a lighting scheme that adjust for daytime shadows as well as night-time enjoyment.

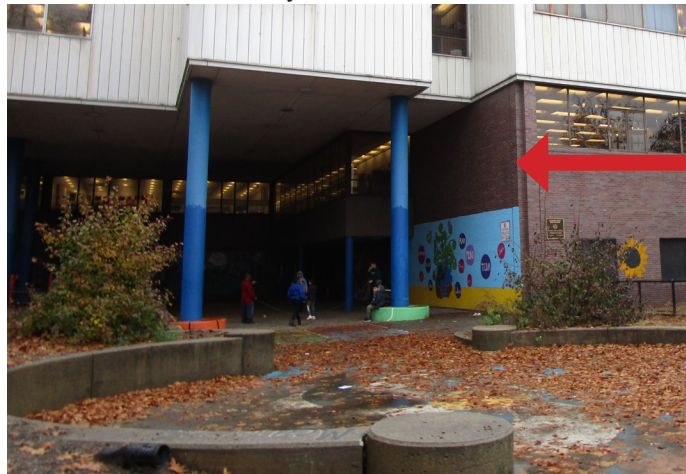
View of Rear Covered Play Area

NOTE: Play area would benefit from new playground furniture

NOTE: Play area needs additional lighting and new surface area
